News Flash

No. 55-29

October 17, 1955

ATTENTION: DEALER SERVICE MANAGER

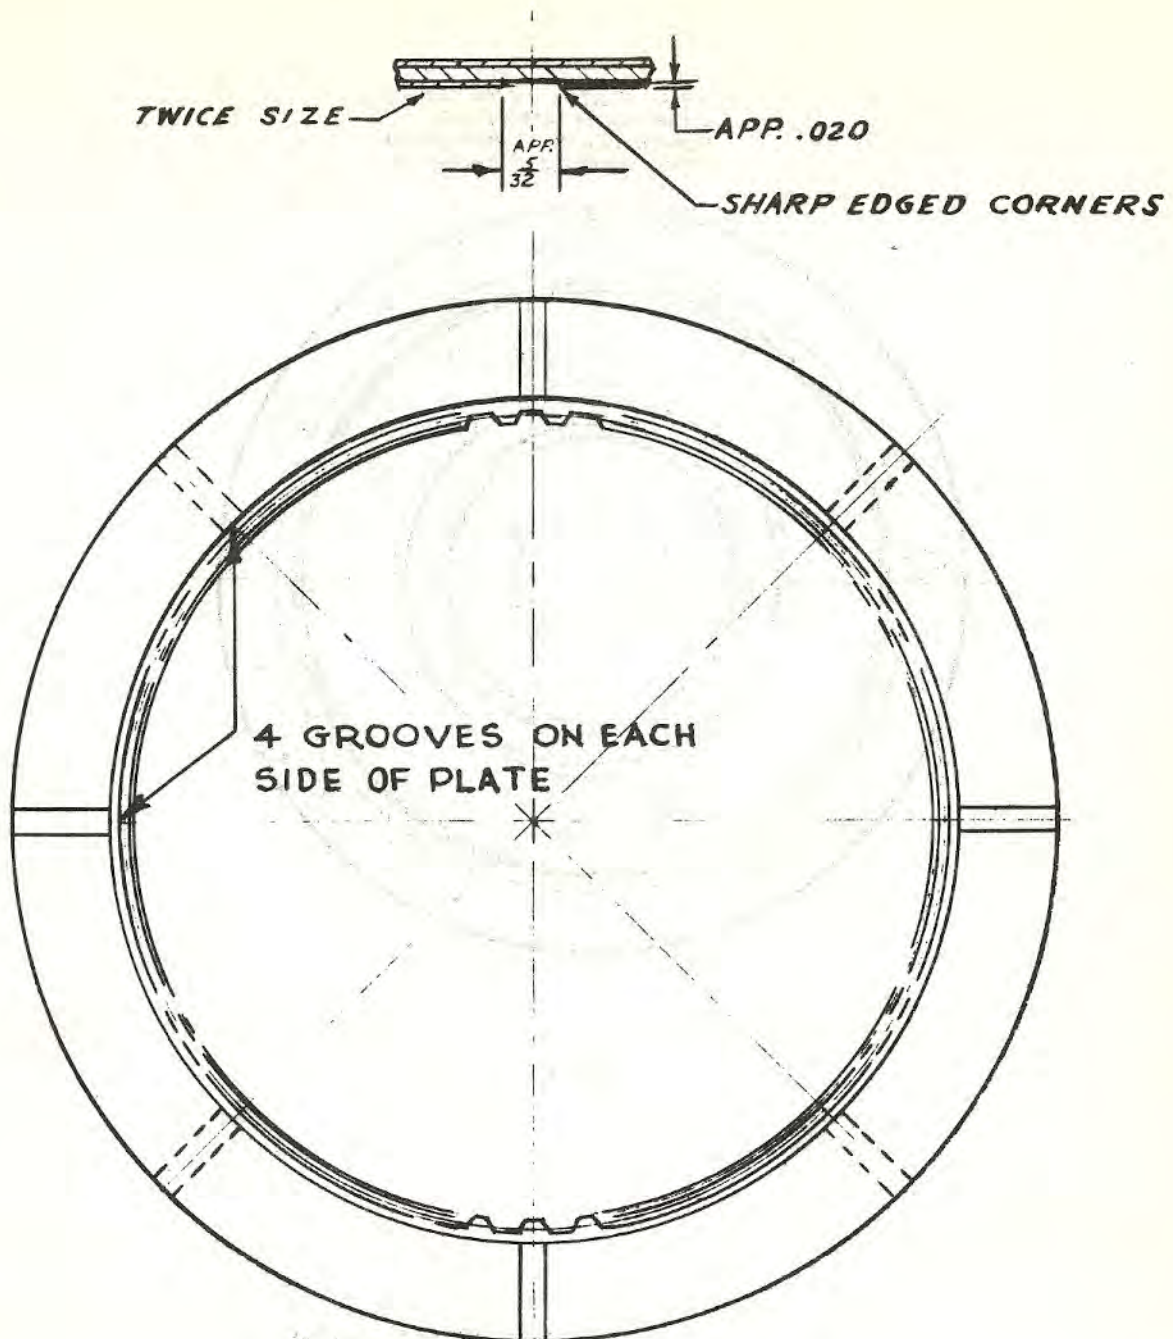
Fig. 2

NEUTRAL CLUTCH DRIVE PLATE MODIFICATION - 8616462

Cut four radial, equally spaced, sharp-edged grooves on each side of the cork facings on the Neutral clutch drive plates. These grooves must be $\frac{1}{8}$ " to $\frac{5}{32}$ " wide and have a depth of approximately $.020$. Note that grooves on one face are spaced between grooves on other face (Fig. 2). Use a square-cornered (mill) file or an end mill mounted in a drill press to perform this modification.

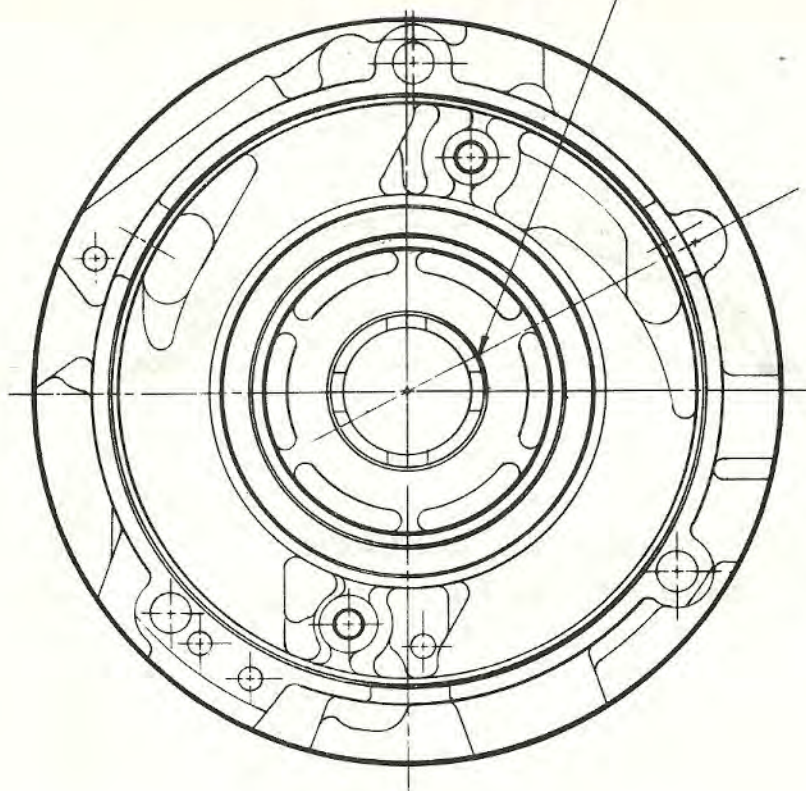
Fig. 3

The measurement must be taken at the point shown since this is the point of greatest thrust. If a $.004''$ gauge can be inserted between the front unit driven torus shaft and the front pump bushing, the front pump and front unit driven torus member should be replaced.

INSERT FEELER GAGE TO CHECK
CLEARANCE BETWEEN PUMP
BUSHING I.D. & FRONT UNIT DRIVEN
TORUS SHAFT O.D. AT THIS POINT

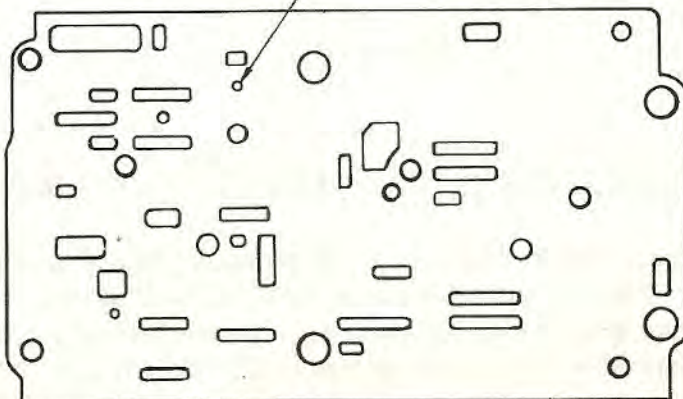
Fig. 4

ENLARGE NEUTRAL CLUTCH
FEED HOLE TO $\frac{3}{16}$ DIA.

Any time the control valve assembly is removed from the transmission the neutral clutch feed passage in the spacer plate should be drilled to $3/16''$ (Fig. 4).

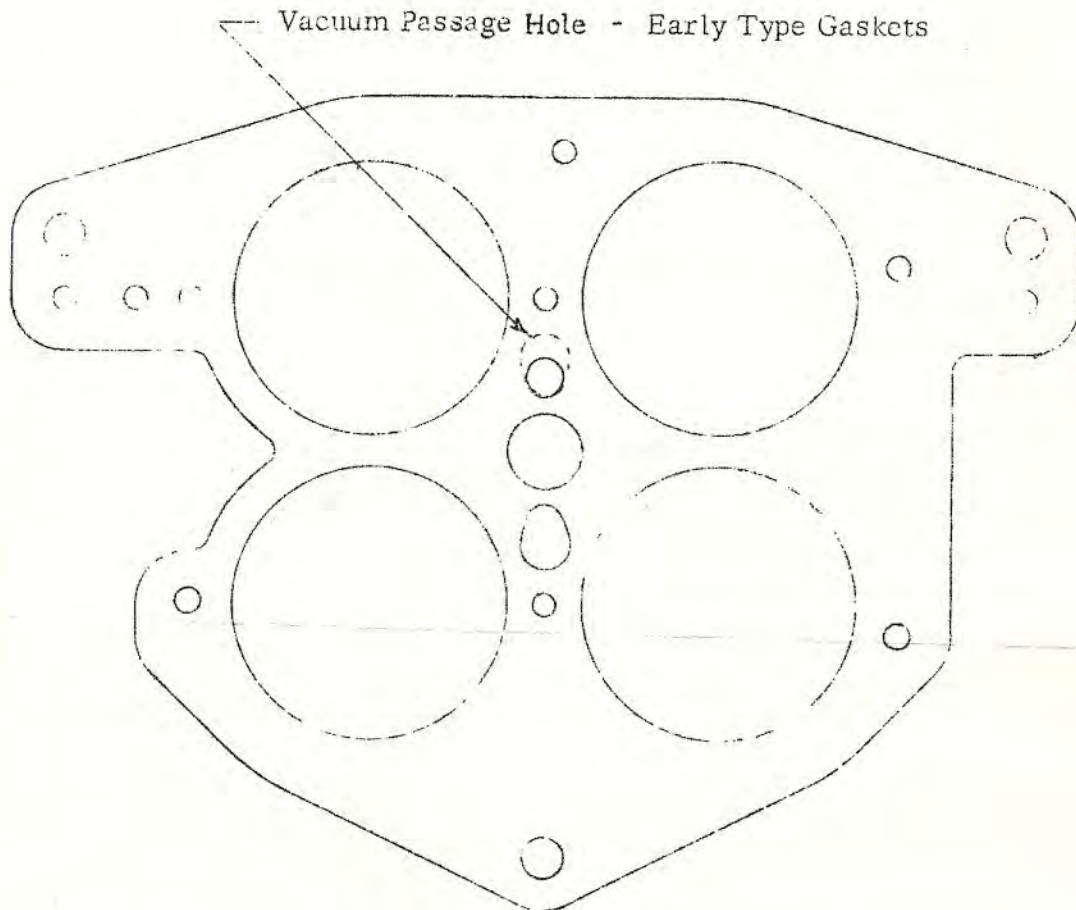
Engine stalling during warm up on cars equipped with the Rochester 4-Jet Carburetor may be due to a leak in the choke piston vacuum passage. A leak in the passage reduces the effect of engine vacuum in opening the choke thereby allowing the engine to "load-up." Investigation of cases of this nature indicates that the usual cause of the condition is a leak at the carburetor throttle body to bowl gasket. The gasket originally used was shaped in such a manner that it could cause a leak between the vacuum passage and one of the secondary throats.

The new gasket is illustrated below. The dotted line on the illustration shows the outline of the vacuum passage hole on early type gaskets.

A new gasket is now being used in production to eliminate the possibility of a leak. The new gasket is available under part number 7009762 through your zone warehouse. All future carburetor gasket and repair kits will contain the new gasket.

To test for a choke vacuum leak, remove the choke housing to manifold pipe and check the vacuum at the choke housing. If vacuum is less than 10 inches, improper choke action will result. Replace the first type gasket with the 7009762 gasket and recheck choke vacuum to be certain condition is corrected. When gasket is being installed inspect upper face of throttle body for smoothness and complete finish. The time allowance for this operation is 1.2 hours.

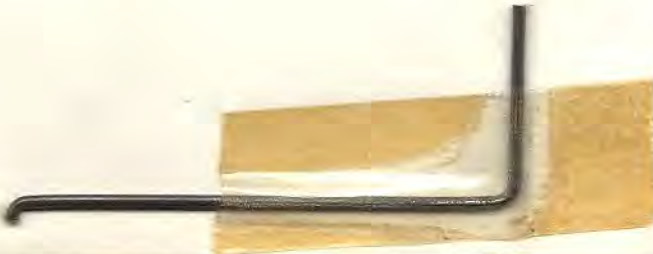
CHECKING REAR CLUTCH APPLY OIL PASSAGE

The rear clutch apply oil passage in the case center support has been enlarged to obtain an improved 2-3 shift. This passage should always be checked before the case center support assembly is put into a transmission, to make certain the improved part is used.

The special tool (.068" gauge) which is furnished no charge attached to this sheet should be inserted into the rear clutch apply oil passage as shown in the line drawing on the reverse side of this bulletin. If the tool will enter the passage, the support can be used. If the tool will not go into the passage, the support should be replaced.

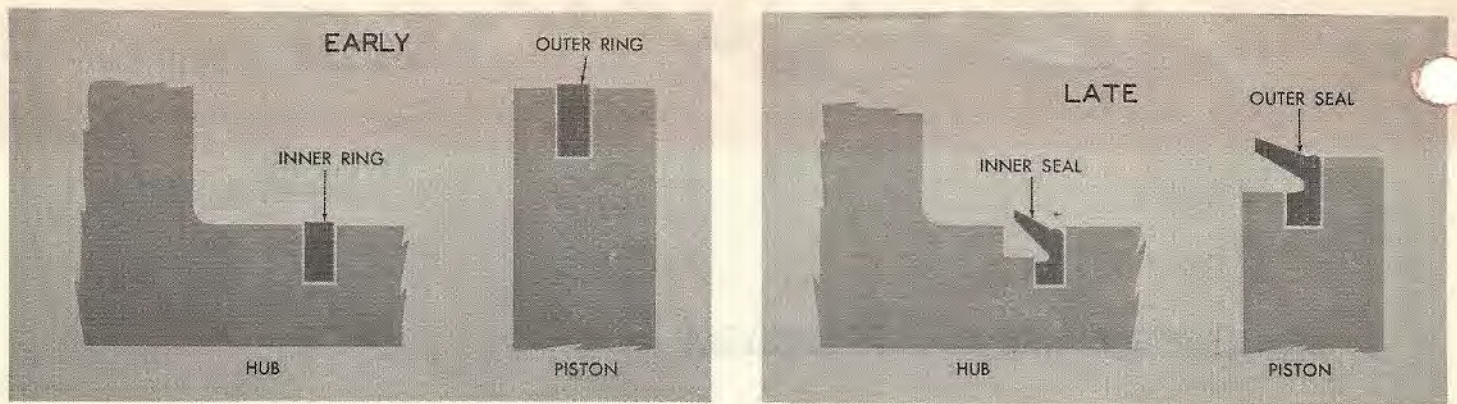
FIG. 1 EARLY AND LATE TYPE HUB AND PISTON

In each clutch all parts must be the same type. For example: If a late type front pump having the step type groove for the rubber seal is installed in an early transmission, the late type overrun clutch piston and rubber lip type inner and outer seals must also be installed.

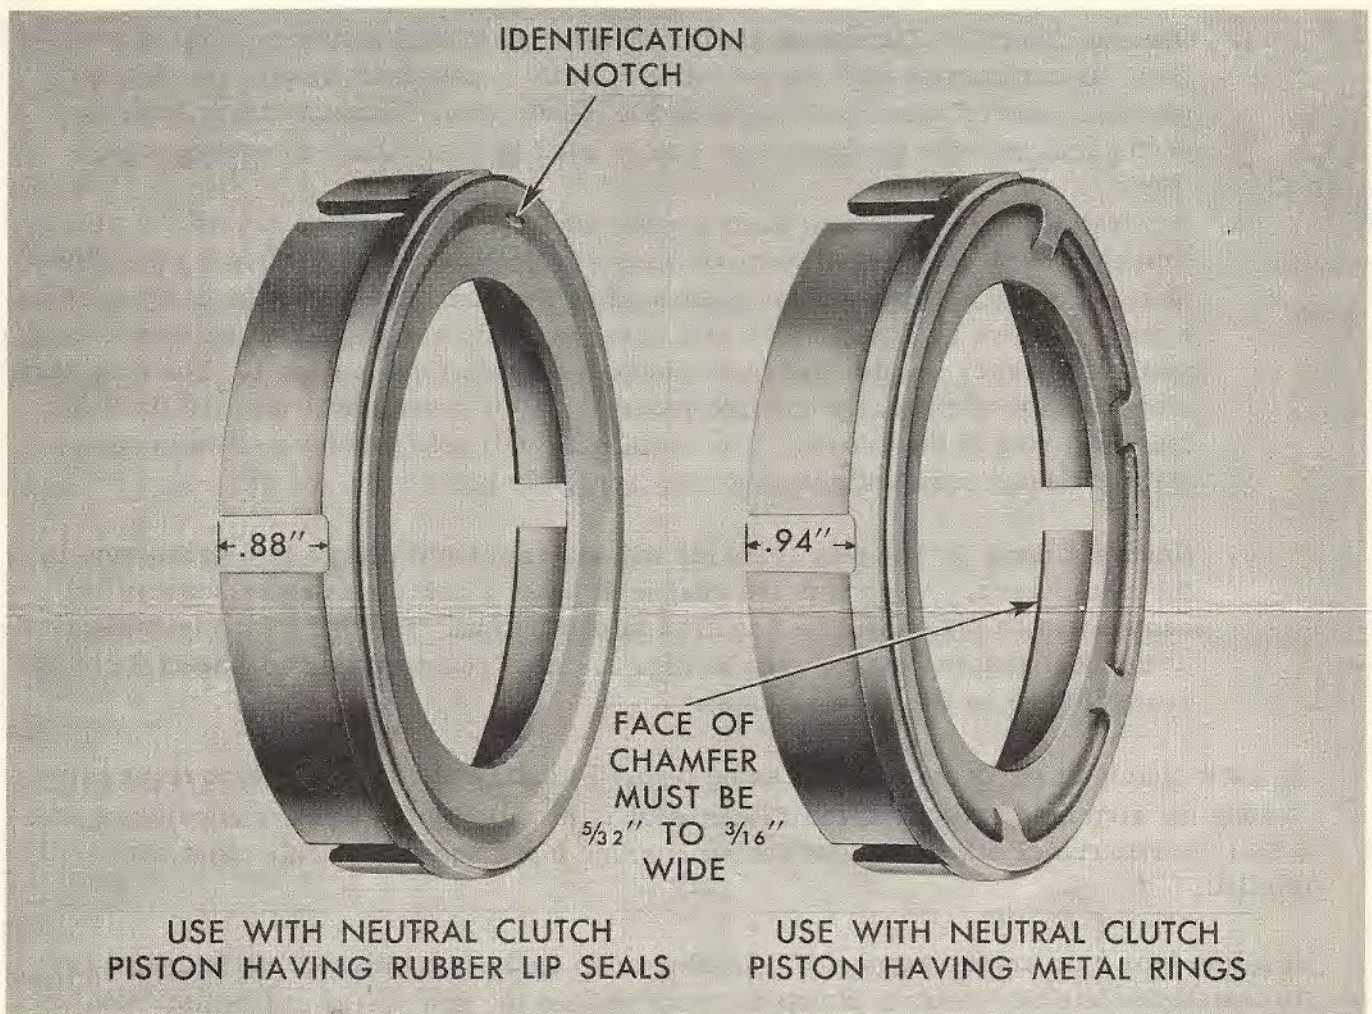
FIG. 2 EARLY AND LATE NEUTRAL CLUTCH DRUM

If a late type case center support is installed in an early transmission, it is necessary to install the late type neutral clutch drum as well as the new piston and seals. Both the early and late type pistons, rings and neutral clutch drum will be serviced. Service front pumps, case center supports and rear pumps of both types will be serviced temporarily to be replaced by the late type only in the future.

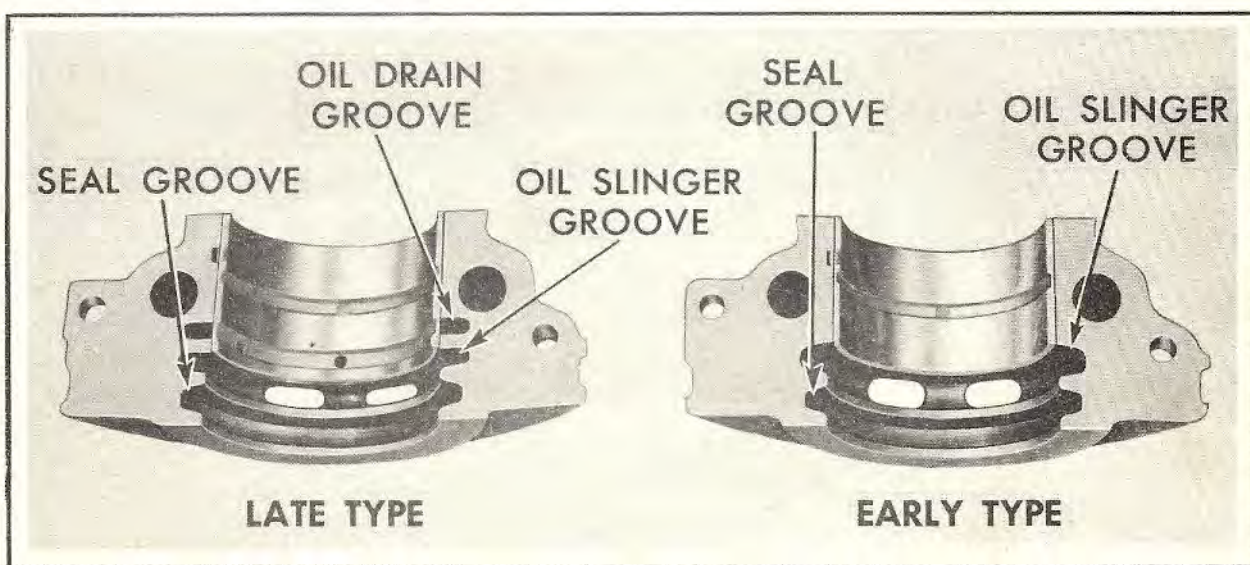
EARLY AND LATE TYPES MAIN BEARINGS

The illustration below illustrates the new rear main bearing design now being used to reduce the possibility of crankshaft rear main oil leaks. As shown in the illustration a groove and three oil drain holes are now incorporated in the bearing shell. These holes index with a machined oil drain groove in the main bearing cap and engine block. The new design allows oil drainage from the crankshaft journal and thereby eliminates oil getting to the packing seal under normal operating conditions. The packing seal is required for acceleration of the car on steep up hill driving.

Engines built on or after January 3, 1956 have the new type rear bearing shells, however, a number of engines were built after December 16, 1955 with the grooves machined in the block and cap but with the first type bearing shells installed. This was done because new shells were not available. If leaks are encountered on engines having the new groove and first type bearing shells, the second type shells may be installed.

When installing the new type shells it will be noted that the upper and lower shells are not interchangeable due to a difference in tang location.

The new bearing shells are released under package number 522825 (one upper and one lower) and are available as a zone warehouse item.

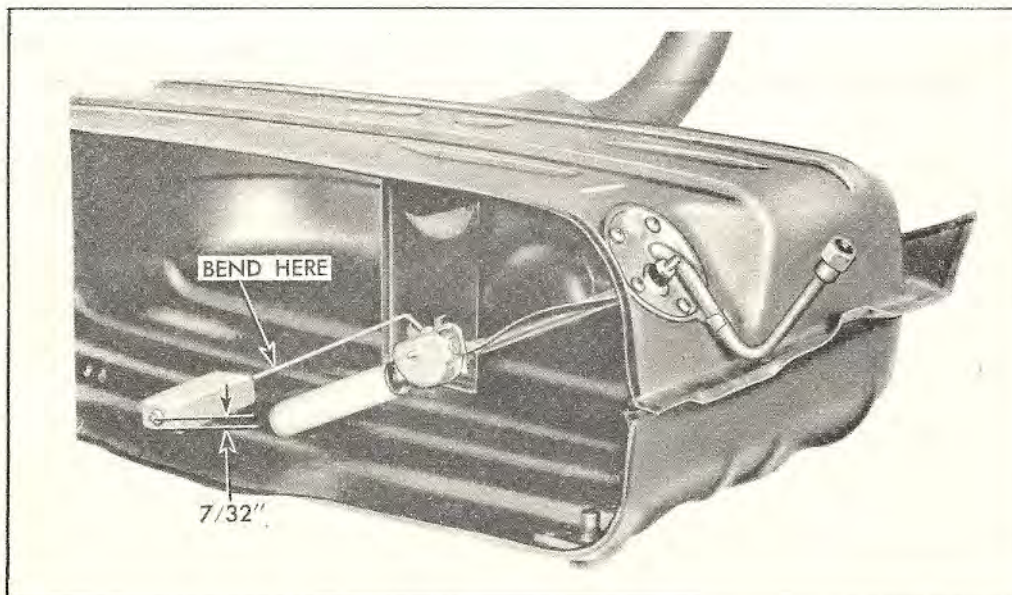
FUEL GAUGE TANK UNIT

Product Information Reports received from the field have indicated complaints on inaccuracy of the instrument panel fuel gauge. Our investigation shows that this is caused by the tank unit rheostat float arm being positioned improperly. In these cases the instrument panel gauge would read empty although there was a reserve in the tank of 6 or more gallons. To correct the condition, remove the unit, remove the filter, place unit in a vise, and bend the float arm so that the float will be $7/32$ " lower as shown in the illustration below. This dimension should be scaled accurately.

The modification should be performed in all cases of complaints of this nature and also on gauge units in dealer stock with the exception of station wagon units which are not affected. The time allowance for removing the tank unit, bending float arm, and replacing is .5 hr.

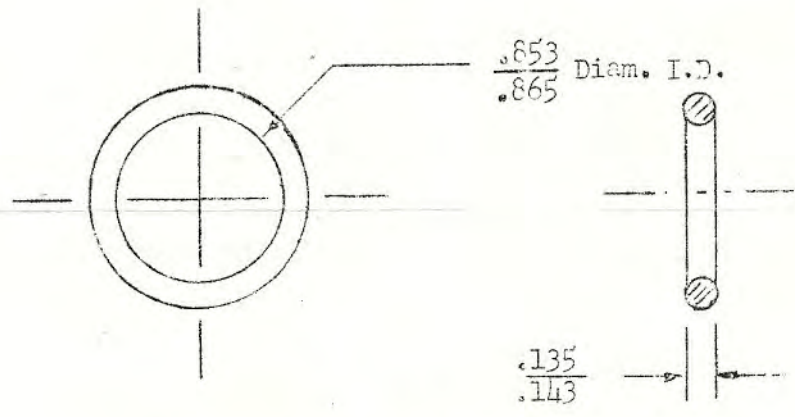
FRONT PUMP INTAKE PIPE SEAL

The "O" ring seal used on the front pump intake pipe is very similar to the "O" ring seal used on the pressure regulator plug. The illustration on the back of this sheet shows the difference between the two seals. It will be noted that the thickness of the rubber used in both "O" rings is exactly the same; however, the diameter of the seal used on the front pump intake pipe is approximately .06" greater.

It is very important that these seals be used correctly. If the pressure regulator "O" ring seal is installed on the front pump intake pipe, a suction leak may occur causing oil starvation and foaming. Conversely, if the intake pipe seal is installed on the pressure regulator plug, an external fluid leak may result.

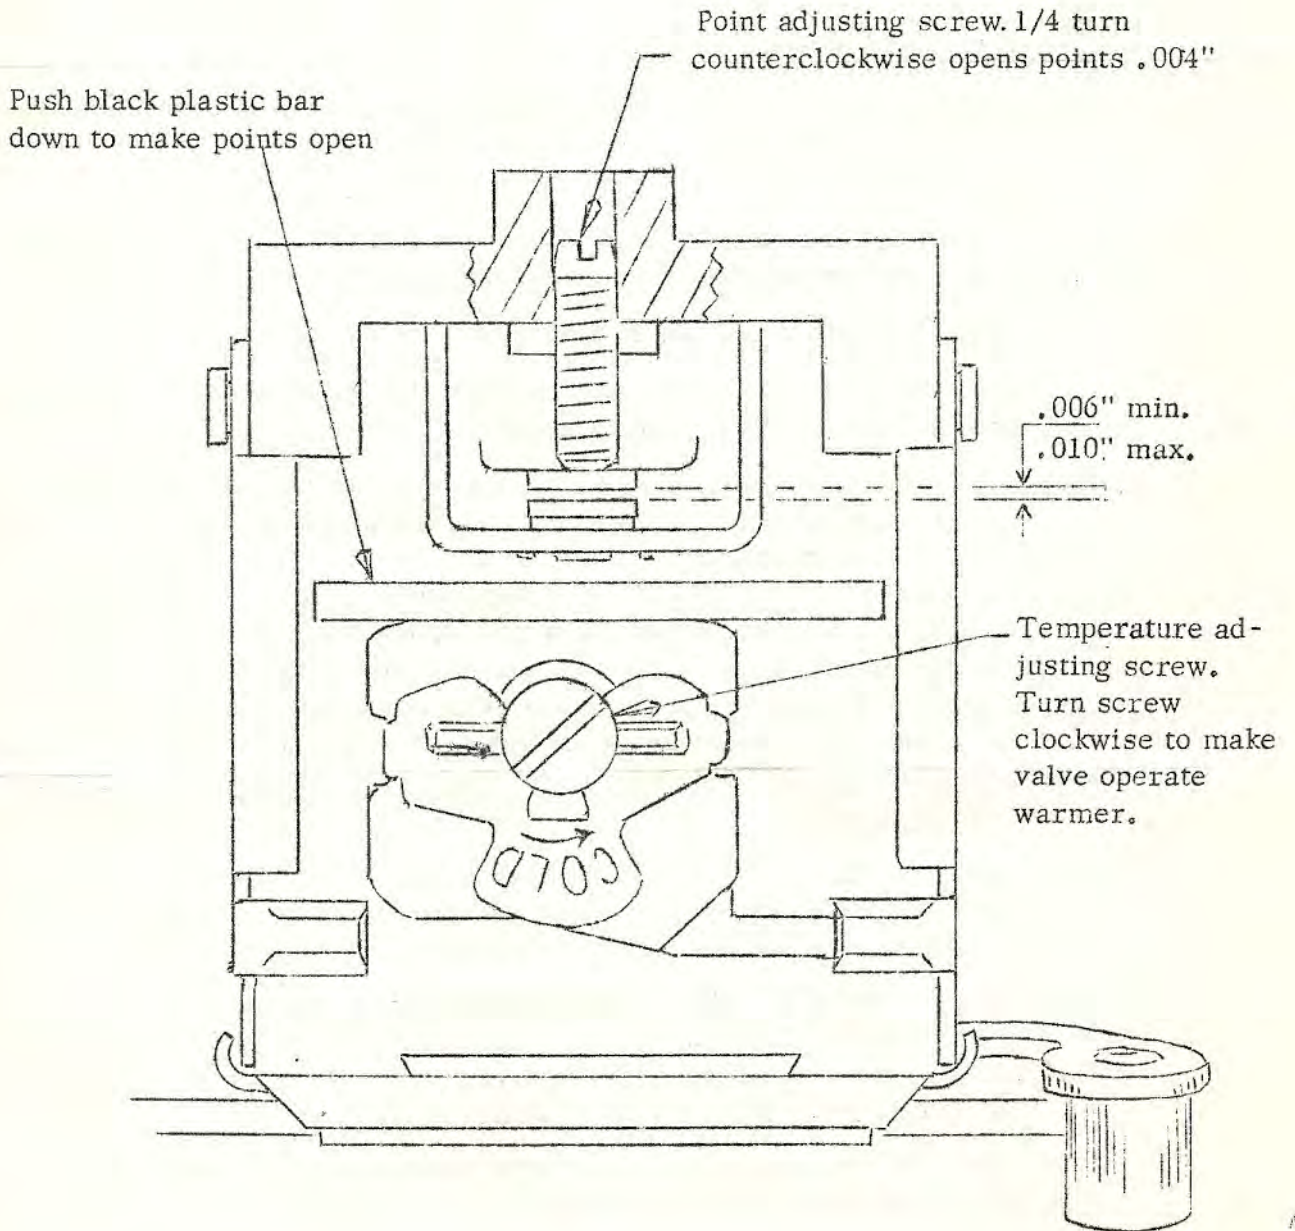
FIG. 1

LOOKING INTO THE RANCOSTAT
WITH THE PRESSED PAPER
DOOR REMOVED

All rancostats in your Parts Department should be checked for proper point opening (.006" minimum and .010" maximum) and adjusted as necessary. The suggested straight time for performing this operation is .7 hr.

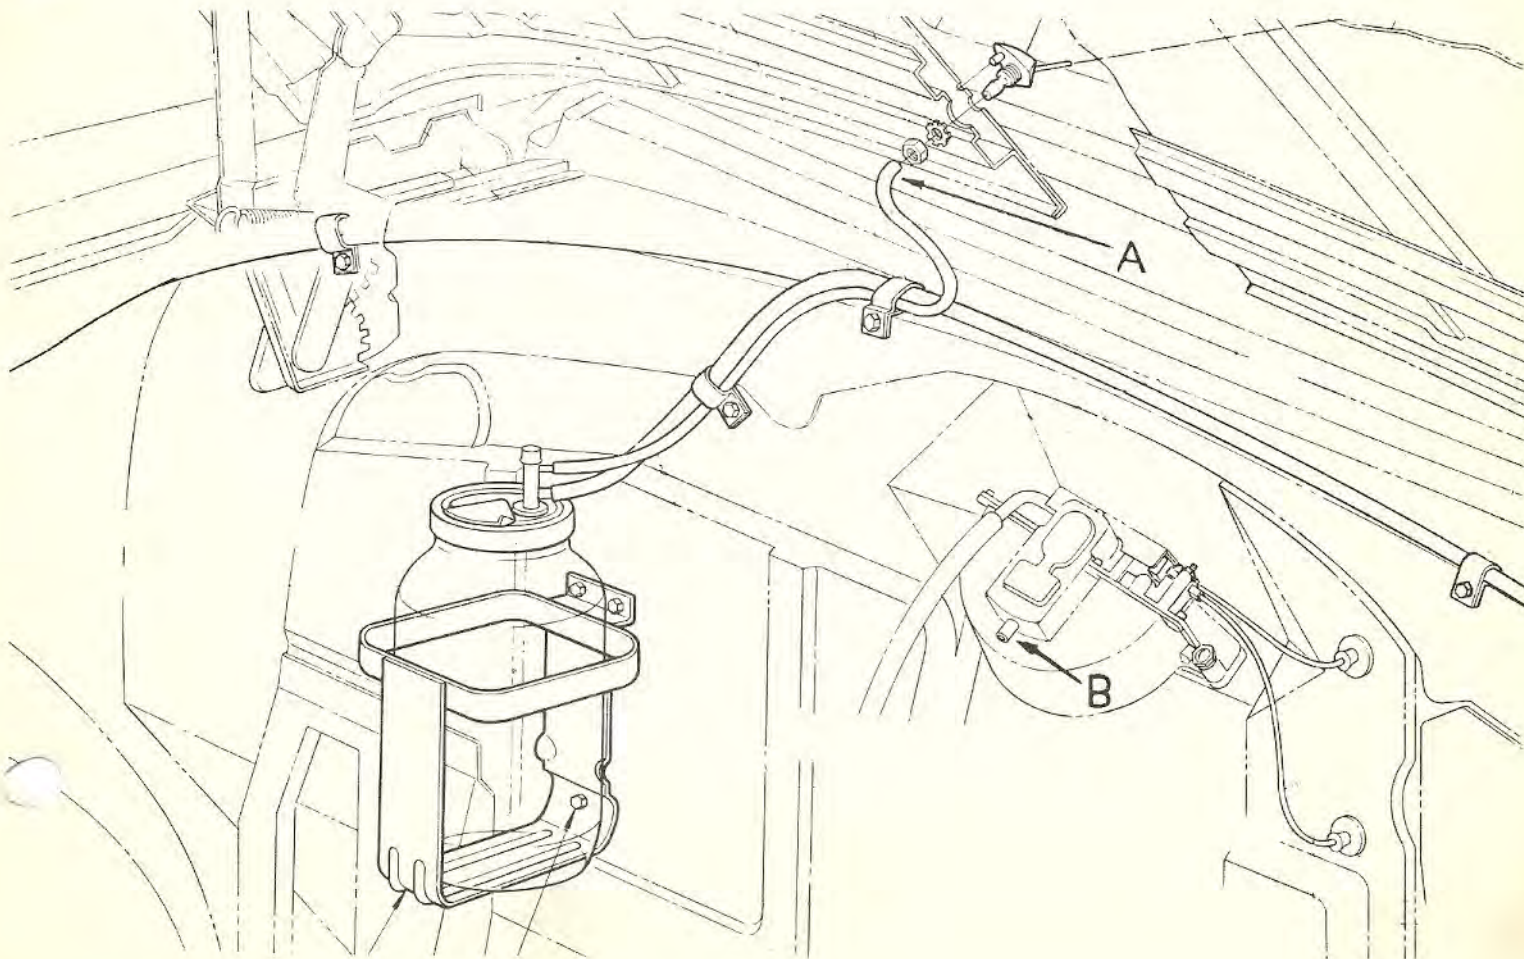
Product Information Reports received recently advise of ruptured vacuum pump diaphragms. Our investigation of these cars has shown that the windshield washer outlet hose has been connected in error to the air intake pipe on the bottom of the windshield wiper motor. When the hose is connected in this manner and the windshield wiper is turned on, the water in the washer bottle is drawn into the engine combustion chamber by way of the vacuum pump. In passing through the pump the water causes a rupture of the vacuum pump diaphragm.

Hose "A" on the drawing below should be attached to the spray nozzle connection on the underside of the hood. Do not connect it to the air inlet pipe, "B", on the windshield wiper motor.
