# PONTIAC

## Service Craftsman News

No. 10 S-267

December, 1954

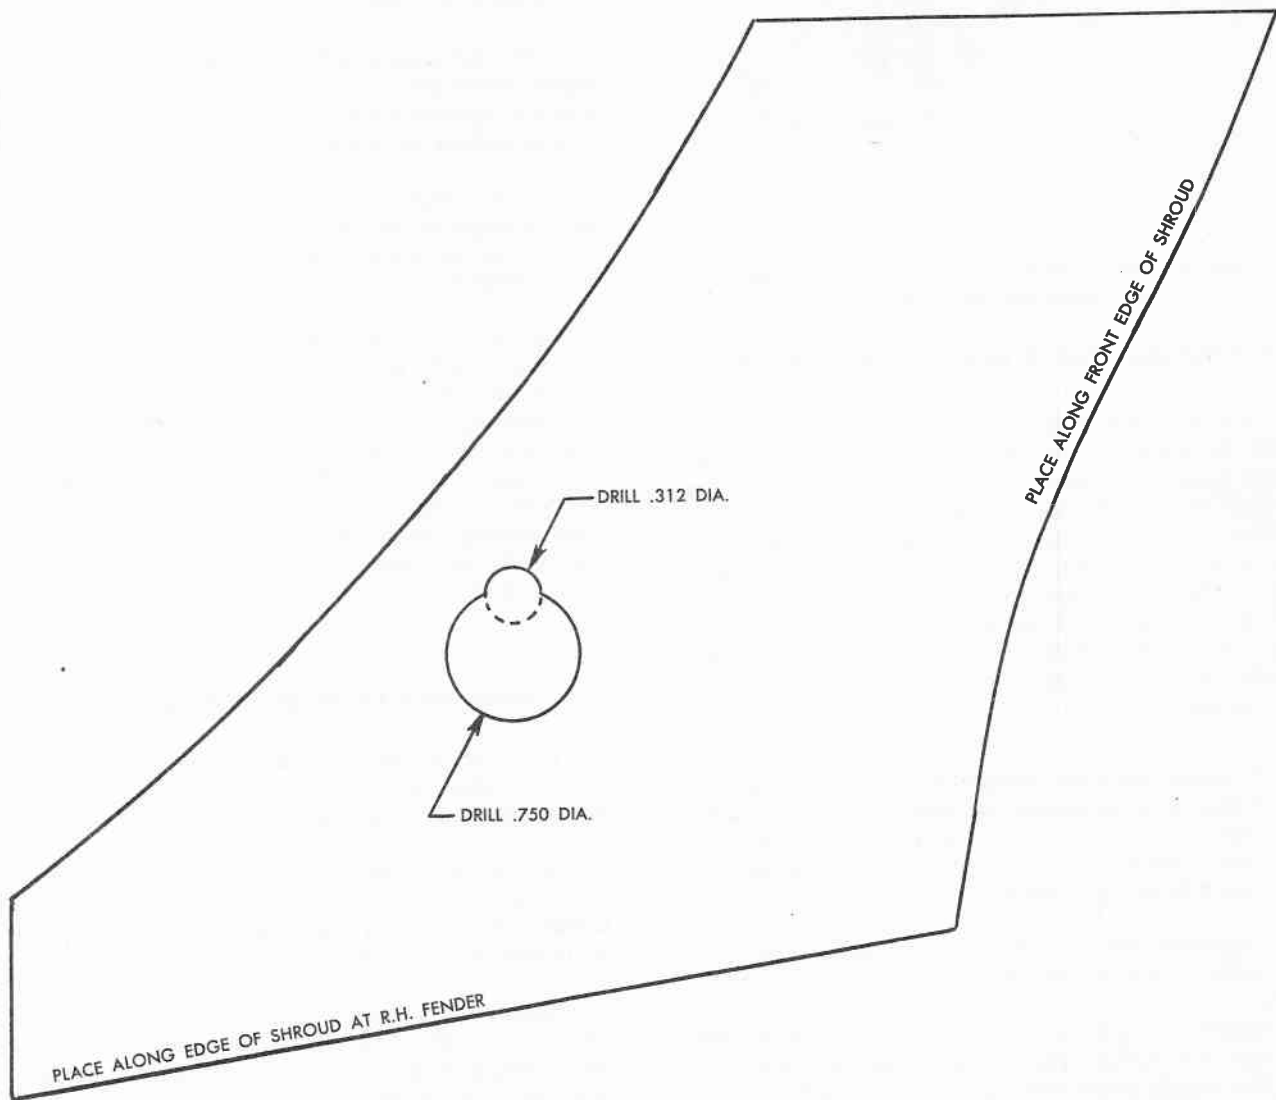
Fig. 1 Template For Correct Location of Antenna Mounting Hole

In some cases the 1955 standard antenna does not have good vertical alignment. The incorrect alignment is caused by an improper position of the mounting hole in the cowl. To correct this difficulty file the hole as necessary using a tracing of Fig. 1 as a guide. It will be necessary to hold the antenna body in the correct position while tightening the body to adapter nut due to the oversize hole.

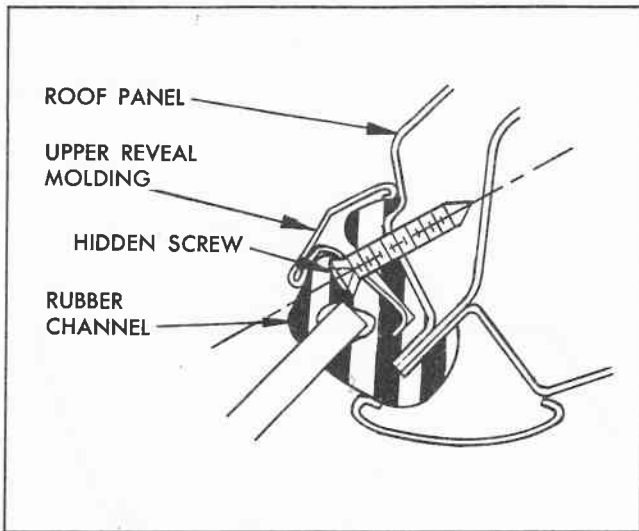
Fig. 2 Cross-Section of Upper Reveal Molding and Windshield Weatherstrip

If a windshield glass is to be removed, a check must be made to determine whether the windshield upper reveal molding is fastened to the roof panel by screws through the tee flange of the molding. As the rubber channel and upper reveal molding must be removed with the glass, any screws fastening the molding to the roof panel must be located and removed before any attempt is made to remove the glass from the body. The following procedure may be used to check for the screws and to remove screws which are located:

2. Lubricate the end of a narrow, thin-bladed putty knife or similar tool with a rubber lubricant.
3. Insert the blade between the upper reveal molding and the rubber channel and slide the blade along the length of the molding. See Figure 2.

4. If the blade strikes the head of a screw, the screw should be removed. This operation may also be facilitated by applying rubber lubricant to the end of the screw driver to permit the screw driver to be more easily inserted between the molding and the rubber channel.

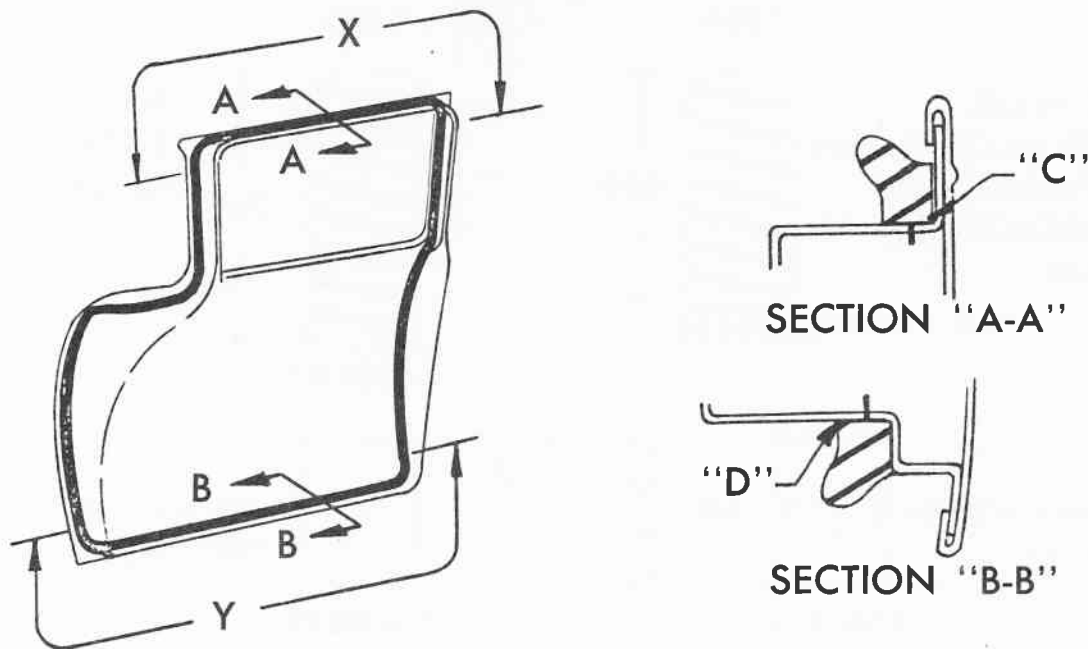
Fig. 3 Locations For Application of Weatherstrip Cement

If a condition is encountered wherein water passes through the weatherstrip clip retaining holes in the door header facing and enters the body on the inside of the door glass, the following procedures may be used to eliminate the condition:

If a condition is encountered where normal water drainage between door panels enters the body through the weatherstrip clip retaining holes along the bottom of the door, it may be eliminated by cementing the inboard edge of the weatherstrip to prevent tilting of the weatherstrip when the door is closed. Remove the weatherstrip along distance "Y" on Fig. 3 and cement to door bottom as follows:

Apply a 1/8 inch bead of weatherstrip cement in location "C" shown in Section "A-A" of Fig. 3 along distance "X" on drawing. Cement may be applied by inserting a pressure type gun behind the weatherstrip.

Cement the inboard edge of the weatherstrip to the door facing at "D" shown in Section "B-B" of Fig. 3 along distance "Y" on drawing, using weatherstrip cement. NOTE: Follow instructions of manufacturer when applying weatherstrip cement.

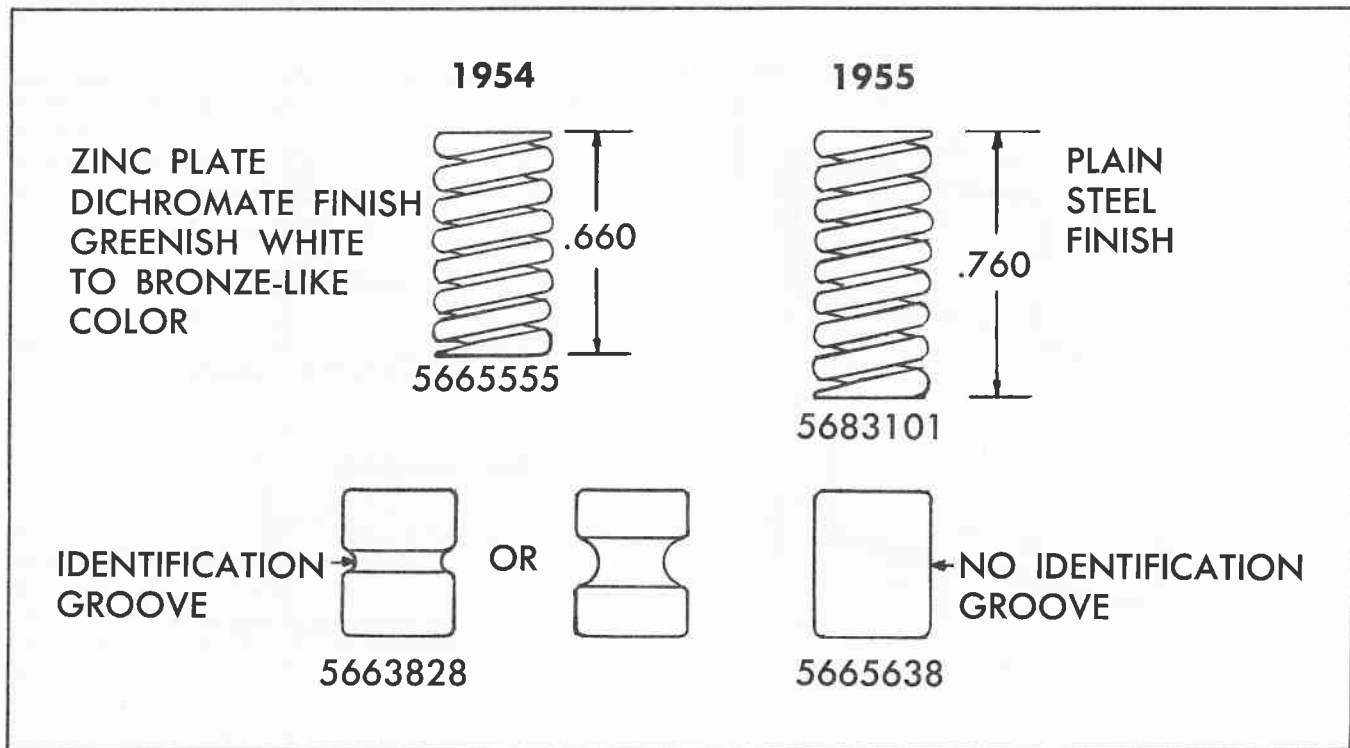
Fig. 4 Comparison of 1954 and 1955 Power Steering Valve Centering Springs and Plungers

The power steering valve assemblies for 1954 and 1955 are interchangeable. Some early production 1955 power steering gears will be equipped with 1954 valve assemblies. The valve centering springs and plungers (page 234 Master Parts Catalogue) are also interchangeable; that is, 1954 springs and plungers may be used as replacement parts in 1955 valve assemblies and vice-versa.

Because of the difference in lengths of springs and plungers for these two years it is imperative that these parts be replaced in sets. A "set" in this instance means two plungers and one spring.

The part numbers, lengths, and identification features of the springs and plungers for 1954 and 1955 are given in Fig. 4.
