PONTIAC

Service Craftsman News

No. 1 S-268

January, 1955

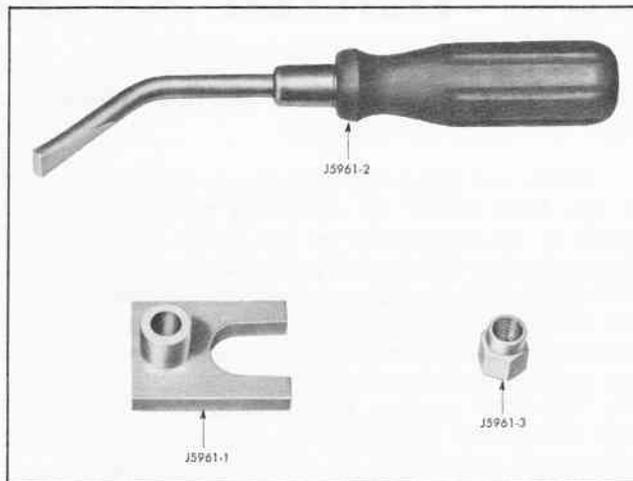
Fig. 1 Valve Stem Oil Splash Shield Installation
Tools - J-5961

In order to reduce to an absolute minimum the possibility of excessive oil consumption, a manufacturing change has been made releasing a new intake valve stem oil splash shield, part #520996. Starting with car engine number 54487 these shields were installed on all engines.

To simplify the installation of this shield and also to replace valve stem oil seals and valve springs, a new tool #J-5961 valve spring compressor set (Fig. 1) has been released. With this tool it is possible to install the oil shields, seals, and springs without removing the cylinder head.

5. Install oil shield (part #520996) on each intake valve spring as follows:
 - a. With #1 piston on top dead center remove intake valve rocker arm retaining nut, rocker arm, and ball.

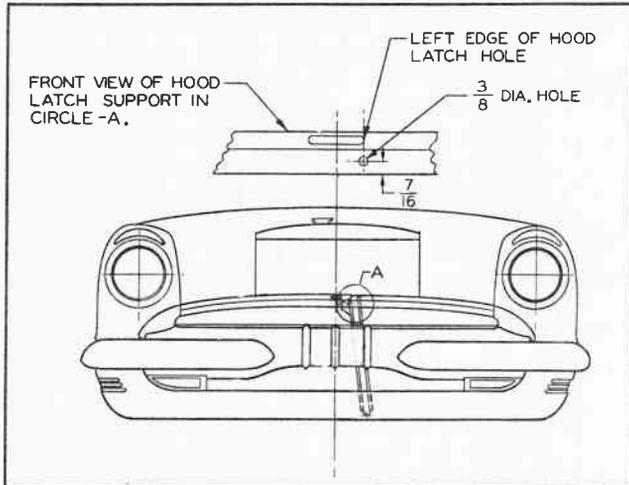
Fig. 3 Installation of #521090 Brace Assembly

In all cases of excess movement of the front of hood first check to be sure that second type hood latch striker and fender support brace assembly (521090) has been installed. All second type braces have a screw installed in the $\frac{3}{8}$ " hole shown in Fig. 3. If the second type brace is not installed, install as outlined in steps 1 through 5 below before proceeding. If this brace is installed, proceed from step 5 and complete balance of procedure.

1. Raise hood.
2. Remove old brace assembly (vertical brace, left of center).
3. Drill a $\frac{3}{8}$ " hole in the Hood Latch Striker and Fender Support from the front of the car as shown in Fig. 3. Punch hole for drill $\frac{7}{16}$ " up from lower edge of Hood Latch Striker and Fender Support and in line with left edge of hood latch hole and on top of the support.

4. Place new brace assembly in position and install all 5 screws finger tight, then tighten. NOTE: Use 445610 screws and plain washers (a number 20-9 x $\frac{3}{4}$ hex head type A Tap zinc-plated) to secure the brace assembly to the support at top. If this screw is not available a $\frac{5}{16}$ bolt, lock-washer and nut may be used.

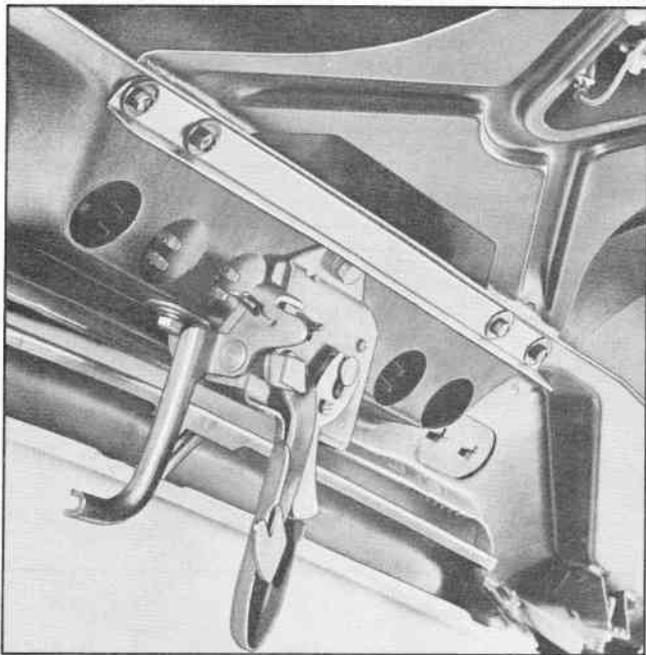
Fig. 6 Reinforcing Strip #521388 Installed

Part of the tendency toward undesirable movement results from flexing of the support under the

front end of the hood to which the latch assembly is fastened. This deflection can be observed at the upper of the three latch attaching screws by moving the latch guide fore and aft while the hood is open. Deflection can be minimized by installing a reinforcing strip, Part #521388, between the four screws, two of which will be seen about 6" to the right and left of the latch (See Fig. 6).

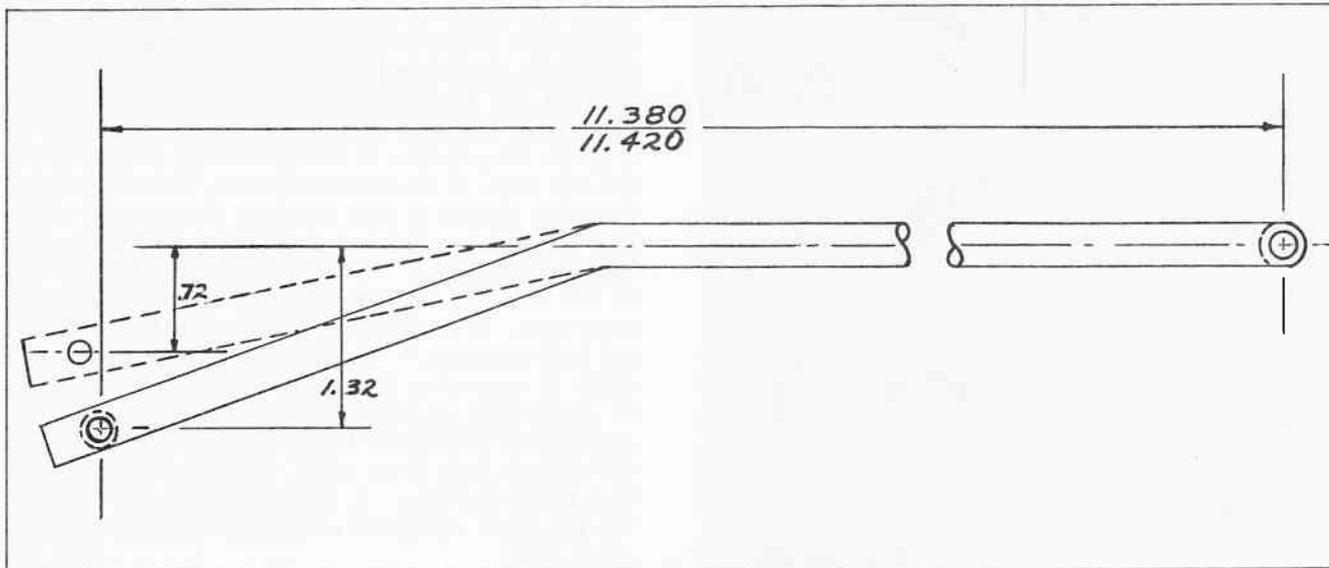
Fig. 8 Bending of Carburetor Throttle Rod

Several reports have been received concerning "lost motion" or "looseness" in the throttle linkage on early production Synchro-Mesh equipped cars. In cases of this nature check the length of the carburetor throttle rod assembly part number 519061 shown on the attached illustration. If the length of the rod is greater than 11.420" it is of the early type and could be causing excessive play in the throttle linkage.

The correction for the condition is to increase the angle of bend in the rod so that it conforms to the dimensions shown in Fig. 8. This has the effect of shortening the rod and taking up looseness in the linkage. This condition has been corrected in production.
