# PONTIAC

## Service Craftsman News

No. 4 S-271

April, 1955

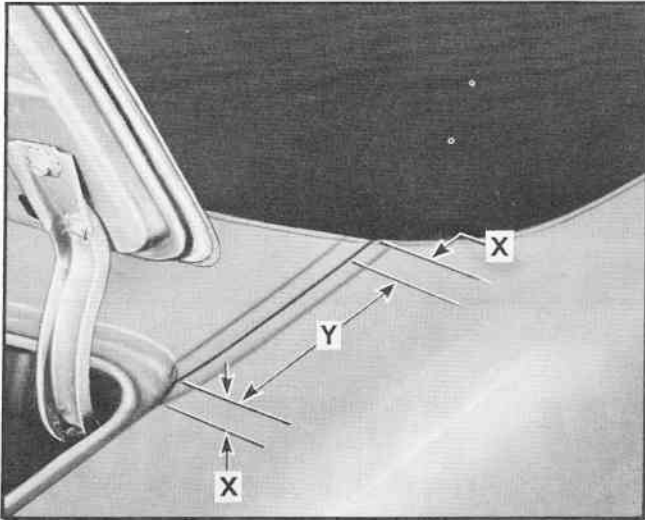
Fig. 1 Rear Quarter Outer Panel Weld  
(Convertible Style Shown)

If a case is encountered where the solder fill on the rear compartment front and shelf panel to rear quarter outer panel and/or the rear end panel to rear quarter side outer panel extension is cracked, the condition may be corrected in the following manner:

1. If one of the rear compartment front and shelf panel to rear quarter outer panel weld joints is affected, remove the back window and all moldings necessary to gain access to the entire weld joint as shown in Fig. 1.

2. Protect all adjacent trim, hardware and painted surfaces against molten solder and the succeeding welding and brazing operations.
3. Remove all of the solder fill from the joint as shown in Fig. 1.

4. Protect the surfaces adjacent to the weld joint from distortion, using a wet asbestos paste.
5. Gas weld for a distance of one inch at each end of the joint shown by distance "X" in Fig. 1.
6. Braze the remaining weld joint as shown by distance "Y" in Fig. 1.

NOTE: It should be noted that the weld joint includes the face of the rear compartment gutter.
