# Service Craftsman News

No. 5 S-272

May, 1955

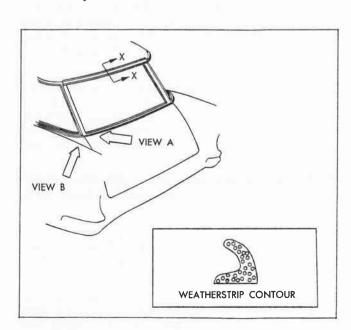
Fig. 5 Safari Lift Gate Weatherstrip Contour

- 1. Check contact of weatherstrip to lift gate:
  - a. Correct any irregularities on gate casting which may be preventing a good seal.
  - b. Check weatherstrip at each leak location. If weatherstrip is damaged, deeply creased or deformed (See inset of Fig. 5 for proper weatherstrip contour), replace with Lift Gate Weatherstrip Assembly Body Side, Part No. 4671303.

c. Check contact of original or new weatherstrip to lift gate across the top of the gate. If sealing lip of weatherstrip does not contact the lift gate or has too little compression, install half round rubber weatherstrip to the lift gate, as shown in Section X-X, Fig. 6. It is important that half round rubber of proper size be used to insure adequate sealing. Generally, 1/4 inch thick half round rubber is satisfactory. (Group 12.269 Part No. 4172355)

Locate half round weatherstrip on gate to contact sealing lip of body weatherstrip as shown. Half round weatherstrip should extend the full width of the lift gate and must be tapered for a distance of 2 inches at both ends to form a smooth sealing surface where ends of half round contact the body weatherstrip. Seal exposed raw sponge rubber with weatherstrip cement at ends of half round weatherstrip to prevent water soaking and resultant swelling.

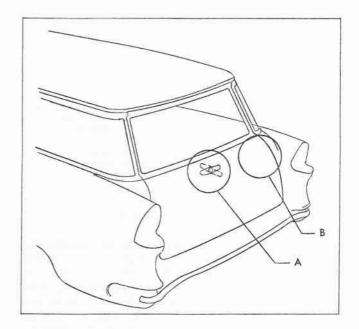
Fig. 10 Tail Gate Handle in "Cocked" position

If the tail gate outside handle remains in a "cocked" position, as indicated by dotted lines in Fig.10, the following steps may be performed to correct the condition.

- 1. Remove remote control assembly.
- 2. Check remote control assembly and outside handle spindle for clips #4158616, indicated in Fig.11. Two (2) clips are required for proper handle spindle to remote control fit. Some early production bodies have no clips or only one clip. Install the proper number of clips where required.
- 3. Reinstall remote control assembly, close tail gate and actuate handle. If handle still remains "cocked", perform steps 4 and 5.
- 4. Remove remote control assembly and both lock assemblies with connecting rods attached.
- 5. Check for clip #4662070, shown in Fig. 12, View "C", used at lock end of connecting rod. If a different type clip is used at one or both locks, remove clip(s) and install correct clip, as shown in Fig. 12.

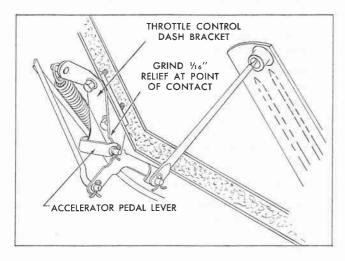
Fig. 15 Point of Interference Between Accelerator Pedal Lever and Throttle Control Dash Bracket

Several Product Information Reports have been received reporting hard starting due to the difficulty in unloading the Carter WGD 4-Barrel Carburetor. If cases of this nature are encountered, which cannot be corrected by a normal unloader adjustment installation of the following parts will be necessary; part number 7008801 Throttle Flex Spring and 521986 Engine Throttle Control Bracket Assembly. These parts are available from the Factory Warehouse only and should be ordered in the usual manner. The following procedure should be followed:

- 5. Check for any interference between accelerator pedal lever and the throttle control dash bracket at the wide open throttle position. See Fig. 15. If possibility of interference exists, grind a 1/16" relief at the point of contact as shown. This step is especially applicable to early production cars that were originally equipped with a two-barrel carburetor and have had a four-barrel carburetor installed in the field.

- 2. Install new Engine Throttle Control Bracket Assembly (#521986). This assembly has been redesigned to transmit unloading effort more effectively to the carburetor.

- 3. Adjust throttle control linkage. Proceed as outlined on pages 39-40 of the 1955 Hydra-Matic Shop Manual steps 1 thru 7. Disregard step 8 and position throttle control intermediate rod as follows: Push throttle control intermediate rod downward until the end of the accelerator pedal rod lever is felt to touch the end of its travel. Shorten throttle control intermediate rod enough to allow 1/8" clearance between end of accelerator pedal rod lever and rubber bellows assembly. See Fig.14. Three turns of the trunnion nut usually gives the correct clearance. This adjustment gives the maximum allowable accelerator pedal travel.

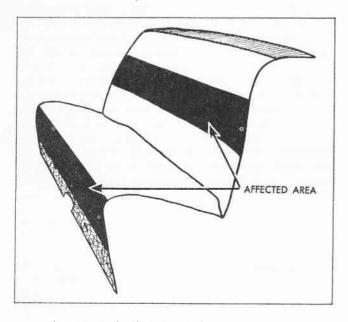
Fig. 17 Dark Cloth Panels (Rear Seat Shown)

When ordering cushions, or back assemblies and cushions, or back trim assemblies for 1955 2511D and 1955 2519D body styles with trim combinations 55260 (blue), 55261 (green), and 55271 (gray), it is necessary to inspect closely the dark cloth panels, because two different kinds of cloth have been used in these areas. (See Fig. 17).

The two types of material are almost identical in color. The only means of visual identification is the difference in weave; one is gabardine, the other is plain cloth with a ripple finish.

Although material will vary among cars, seat assemblies in a particular car will use the same kind of cloth; that is, it will be either "Plain Cloth" or "Gabardine". To insure getting a replacement trim assembly that will match the rest of the trim, inspect the dark cloth areas very closely to determine the specific material used. Then indicate on your order either "Gabardine" or "Plain Cloth", whichever is desired.
