# PONTIAC

## Service Craftsman News

No. 4 S-282

# STRATO-FLIGHT TRANSMISSION PARTS CHANGED

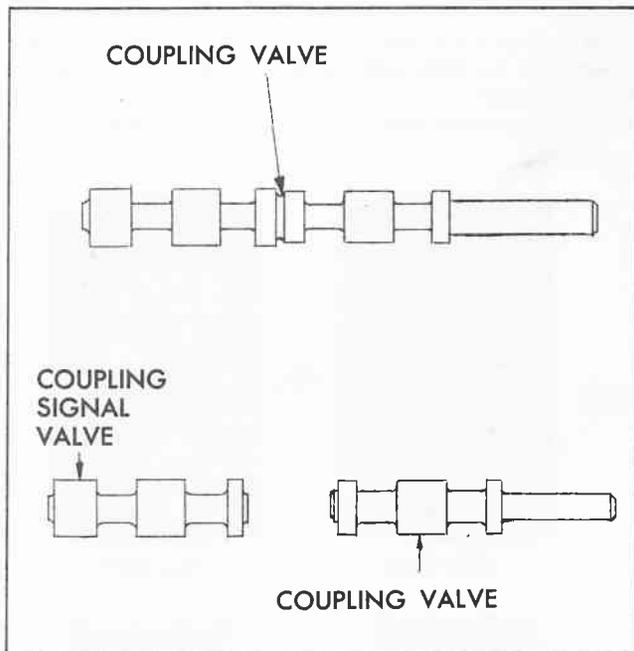
The original one piece coupling valve in the over-run clutch valve body has been replaced by two separate valves. These valves are the coupling valve and the coupling signal valve (Fig. 1). When in their operating position, the two valves have the same arrangement of lands as the original one piece valve.

The use of two separate valves improves the valve action with cold oil.

The governor boost valve has been modified and an orifice has been added in the passage which carries governor boost oil to the end of the coupling signal valve. These two changes reduce the possibility of the coupling and coupling signal valve oscillating and clicking at low speeds due to pulsations in pressure from the governor.

Fig. 1 First and Second Type Coupling Valves

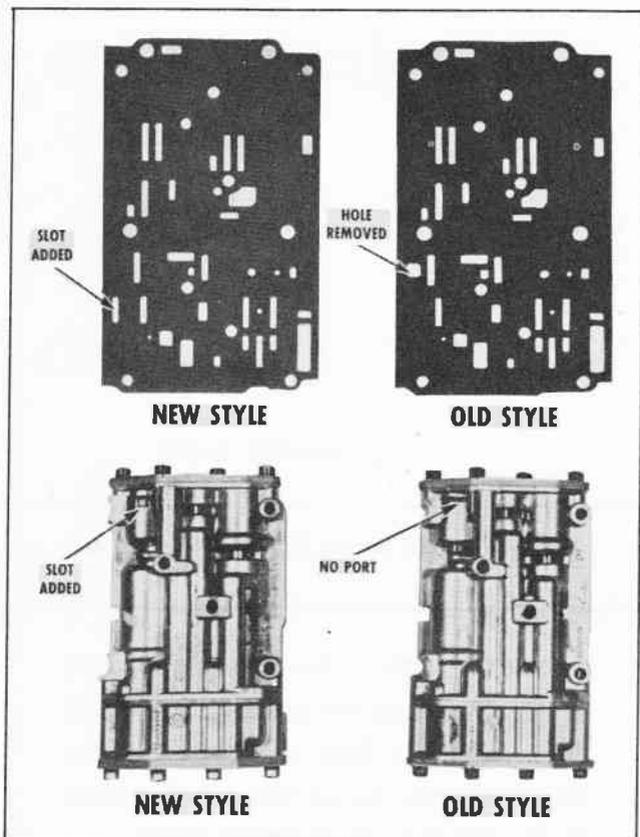
In a few very early production control valve assemblies governor boost pressure was exhausted through a hole in the spacer plate into the governor line (when the governor boost valve was closed). In later production governor boost pressure is exhausted directly to the outside through an external slot in the valve body (Fig. 2). The spacer plate used with this late type shift valve body has a slot near where the hole was located in the early plate.

If a late type shift valve body is accidentally installed on an assembly with the early type spacer plate, governor pressure will be exhausted. As a result the transmission will not shift out of first speed.

Fig. 2 Shift Valve Body and Spacer Identification

When a new shift valve body is installed on an early assembly (all service parts are the late type), the spacer plate must also be replaced.

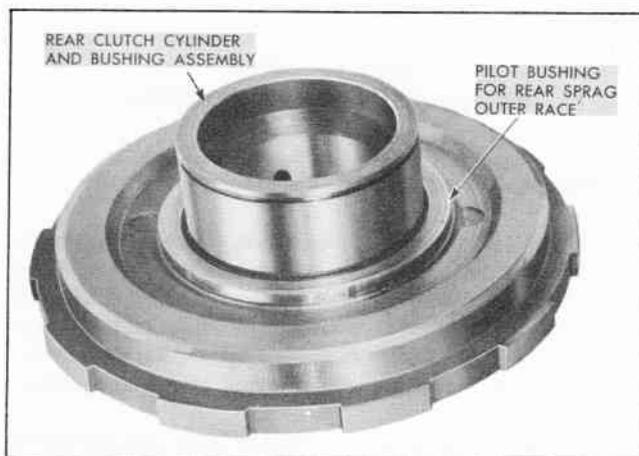
In early production the rear sprag outer race was lubrited so that it would have a suitable bearing surface where it is piloted on the rear clutch cylinder and bushing assembly.

A pilot bushing has now been added on the clutch cylinder and bushing assembly (Fig. 3). With this bushing the lubriting of the rear sprag outer race is no longer necessary and has been eliminated.

Fig. 3 Rear Clutch Cylinder and Bushing Assembly

The service rear sprag outer race will continue to have a lubrited surface so that it can be used with either type clutch cylinder and bushing assembly.

Along with the new unlubrited rear sprag outer race a bronze rear sprag outer race retainer will be used. The early type retainer must not be used with the new sprag outer race and will be discontinued when present stocks are exhausted. The bronze retainer can be used with both early and late outer races.
