# PONTIAC

## Service Craftsman News

No. 8 S-286

August, 1956

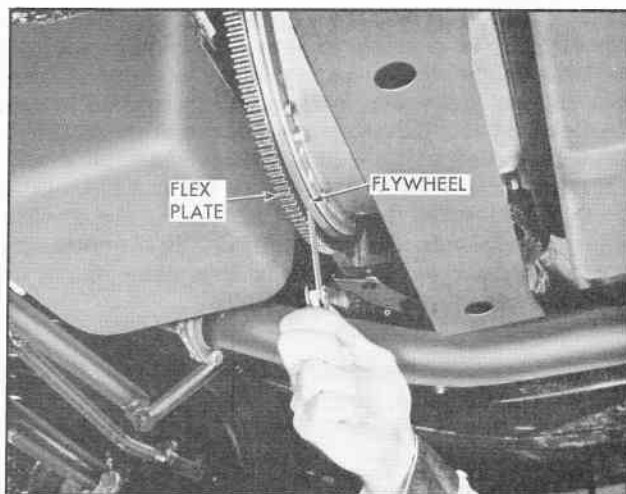
When attaching the torus cover and flywheel to the flex plate it is desirable to have no more than .024" draw between the flywheel and the flex plate. Draw is the amount of gap between the flywheel and the attaching pads on the flex plate when the flywheel hub (or pilot) is seated in the crankshaft. Most of the transmissions built to date have considerably more than .024" draw and, in some cases, the draw varies between mounting pads. When this draw is taken up by tightening the flex plate attaching nuts, distortion of the connecting parts occurs affecting smoothness and durability.

Fig. 1 Measuring Clearance Between Flywheel and Flex Plate

1. Proceed according to steps 1-8 under "INSTALLATION OF TRANSMISSION" on page 104 of Part I in the 1956 Hydra-Matic Manual. Be especially careful to check as outlined in step 4 to see that the flywheel pilot has properly entered the end of the crankshaft.
2. Rotate flywheel to position one flex plate mounting pad down. Push forward lightly on flywheel to seat it against crankshaft. Measure clearance between pad on flex plate and flywheel, using feeler gauges (Fig. 1) insert shims part no. 523087 (approximately .011") and part no. 523088 (ap-

proximately .030") to reduce this to .013" - .024" clearance (Fig. 2). Coat shims with petrolatum so they will remain in position. Do not install nut until shims have been installed at each attaching pad since it will cock the assembly giving a false measurement of clearance at the other pads.

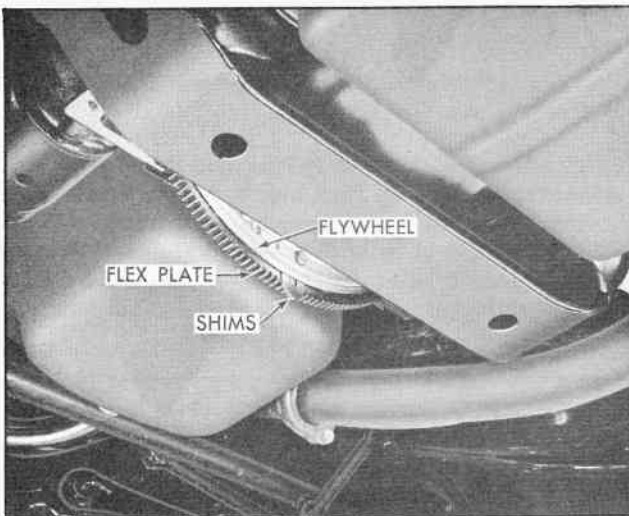
Fig. 2 Shims Installed Between Flywheel and Flex Plate

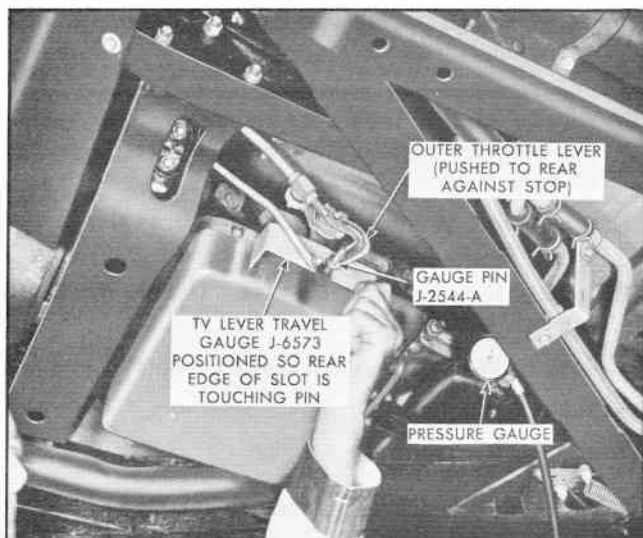
The TV pressure tap has been added to make it possible to test and adjust TV pressure when it is a suspected cause of improper 2-3 shift action or improper shift pattern. (Insufficient TV pressure may result in slippage during the 2-3 shift - excessive TV pressure may result in harsh 2-3 shift accompanied by a metallic clunk). A new tool (TV Lever Travel Gauge J-6573) is required and is available from Kent-Moore Organization at a nominal cost. A pressure gauge for this operation is also being developed and will be released as soon as available.

Fig. 3 Testing TV Pressure

5. Insert gauge pin J-2544-A in TV lever and move TV lever to rearmost position.
6. While holding lever in this position, place TV lever travel gauge J-6573 against side of transmission pan so that gauge pin in lever is touching rear of slot (Fig. 3).

7. Holding gauge J-6573 securely against side of pan, move TV lever forward until gauge pin in lever touches front of slot and read TV pressure on pressure gauge. Pressure should be 20-22 lbs.

8. If pressure is not correct, stop engine, drain fluid from transmission and remove pan. Move TV stop pin on control valve rearward to reduce TV pressure or forward to increase TV pressure. Moving the pin .030" will change TV pressure about 5 lbs.

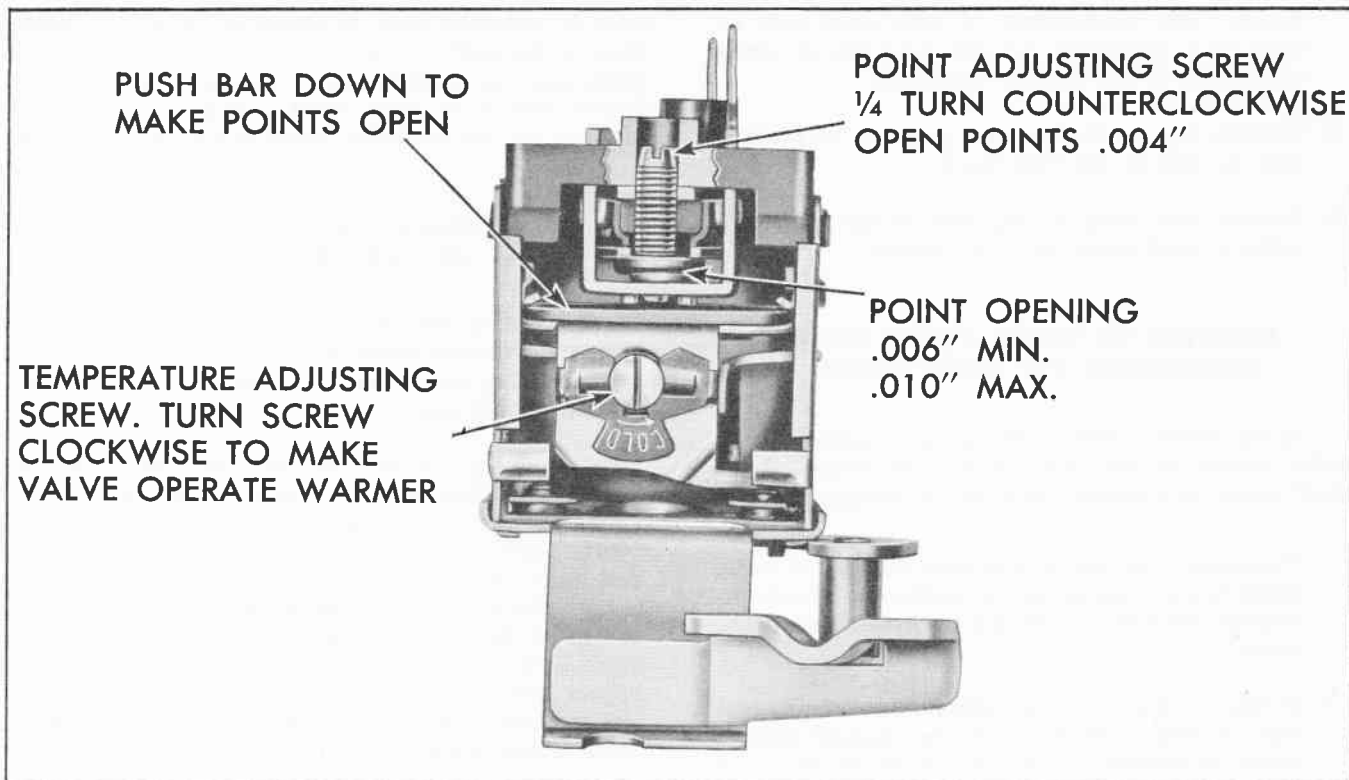
Reports are being received of intermittent operation of the air conditioning unit. The unit operates satisfactorily for a time but then nozzle air temperature increases. Investigation of these reports indicates that this condition is caused by the freezing of accumulated moisture on the surface of the evaporator core.

Fig. 4 Air Conditioning Rancostat

1. Check for heat leak at heater.
2. Perform operational check, making sure suction pressures, discharge pressures, and nozzle temperatures are all in accordance with the specifications on Page 49 of the 1956 Air Conditioning Manual.
3. If all pressures and temperatures are within specifications, turn engine off and remove the thermostat and air distributor as an assembly for the following checks:
  - a. Lift the pressed paper door on the thermostat.
  - b. Move the cam lever at the bottom of the rancostat (thermostat) towards you as you face the end of the rancostat just exposed by removing the door.
  - c. Pressing down on the plastic bar, which is in the center of the opening, Fig. 4, observe the distance that the rancostat points open. This

distance should be a minimum of .006" and should not exceed .010". If points appear to be burned or oxidized, very light filing is suggested. (Use a thin or very fine riffler file.) If it is necessary to adjust these points, use a screw driver and turn the screw on the upper portion of the rancostat the necessary distance to give you the proper gap (1/4 turn of this screw counterclockwise will increase the point opening .004"). As the top of the screw is cemented, it will require a screw driver of the right size and properly sharpened to effectively turn it, otherwise the head of the screw will be damaged.

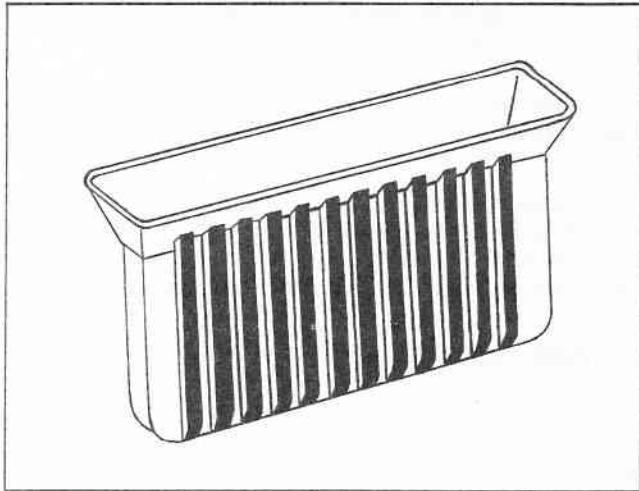
Fig. 5 New Type Striker Sleeve

To eliminate squeaks between the side roof rail mechanical sealing strip striker sleeve and the door ventilator assembly on Catalina Coupes, a new striker sleeve has been released to production. This new striker sleeve incorporates serrations on the contacting surface (Fig. 5). The new striker sleeve is available for field use under Part Number 4690492.

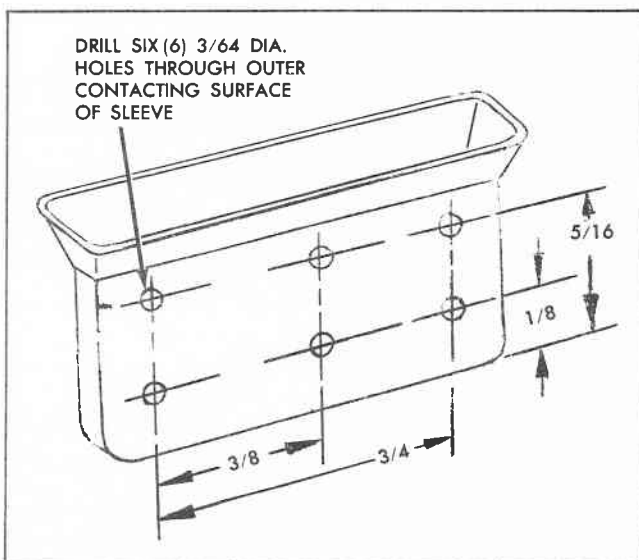
Fig. 6 Reworked Striker Sleeve

If the new striker sleeve is not readily available, the old striker sleeve may be reworked as shown in Fig. 6. The reworked striker sleeve must be lubricated on the inside with Lubriplate lubricant before installation. This will allow lubricant to fill holes in striker sleeve when the striker is installed.
