PONTIAC

Service Craftsman News

No. 9 S-287

September-October, 1956

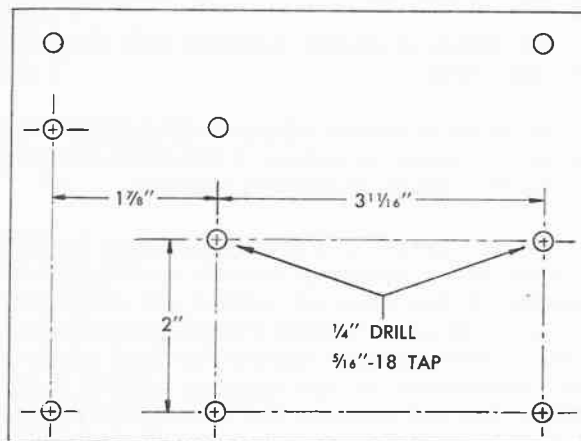
Fig. 1 J-5923, Carburetor Holding Stand Modification

The new 1957 Rochester two-barrel carburetors will have a different throttle body. The carburetor holding stand J-5923 must be modified to accommodate usage on off the car repairs.

The holding stand can be used satisfactorily if it is modified according to the dimensions shown in Fig. 1. Two new 1/4" holes must be drilled and tapped with a 5/16"-18 tap in the location as shown.

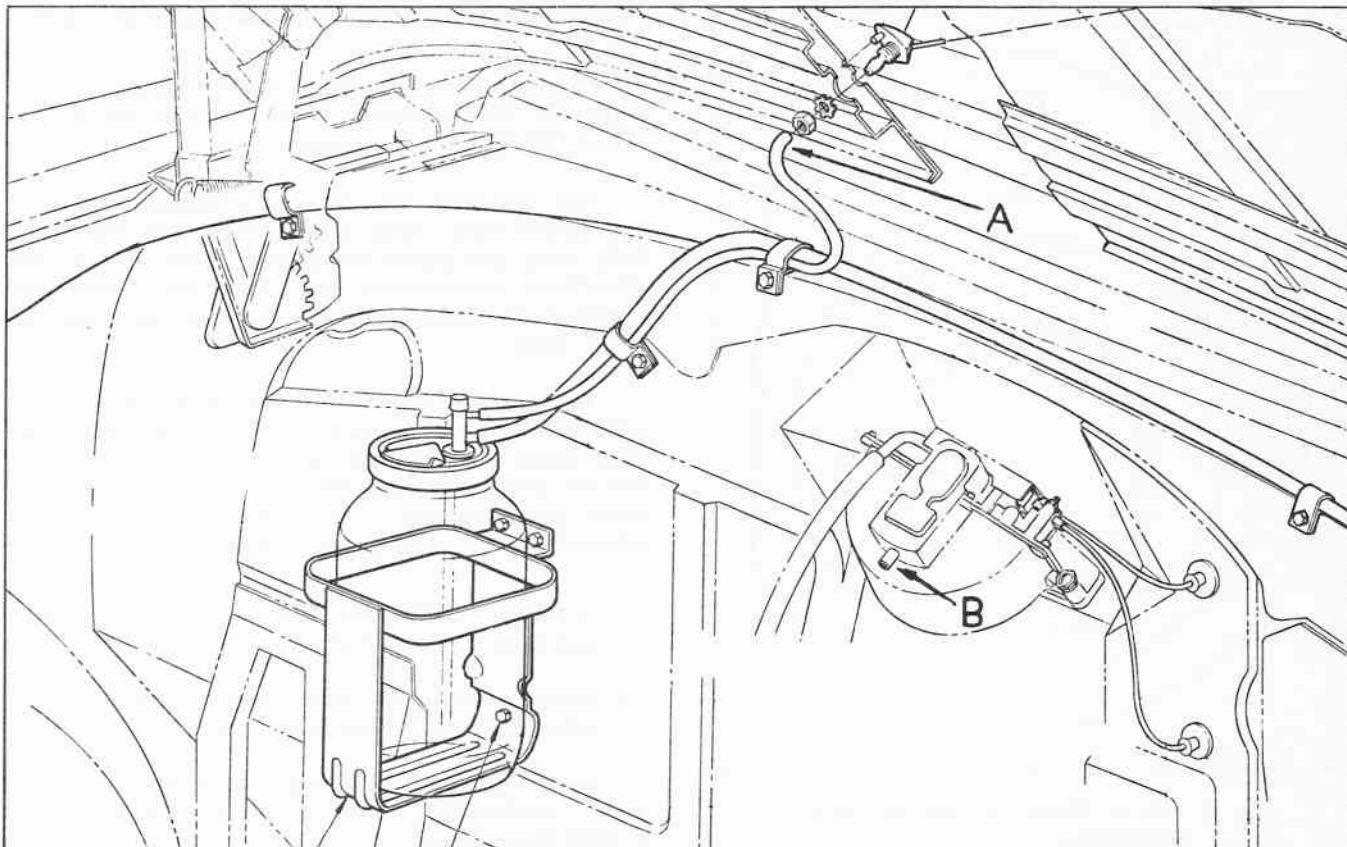
Fig. 2 Correct Installation of Windshield Washer Outlet Hose

Product Information Reports received recently advise of ruptured vacuum pump diaphragms. Our investigation of these cars has shown that the windshield washer outlet hose has been connected in error to the air intake pipe on the bottom of the windshield wiper motor. When the hose is connected in this manner and the windshield wiper is turned on, the water in the washer bottle is drawn into the engine combustion chamber by way of the vacuum pump. In passing through the pump the water causes a rupture of the vacuum pump diaphragm.

Hose "A" (Fig. 2) should be attached to the spray nozzle connection on the underside of the hood. Do not connect it to the air inlet pipe, "B", on the windshield wiper motor.

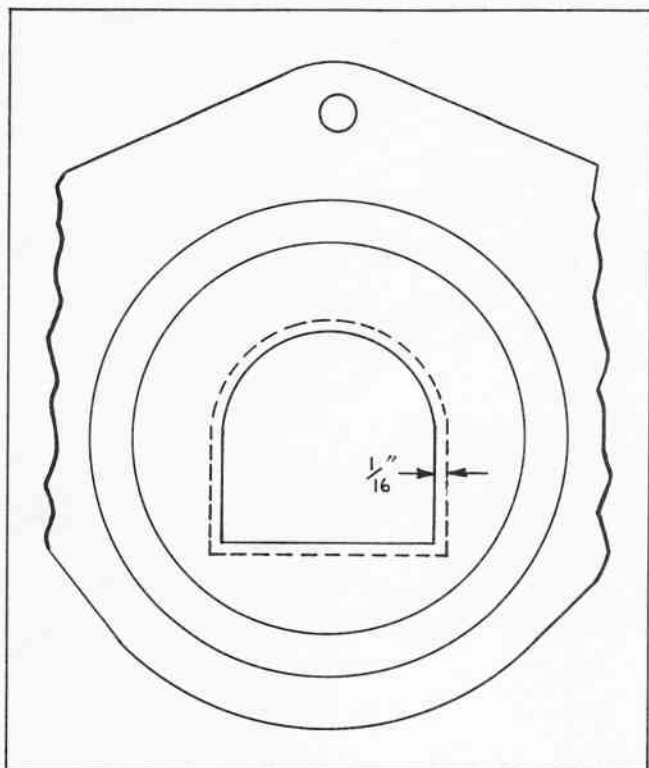
Fig. 3 J-6116, Clutch Unit Holding Fixture Modification

The gear ratio of the 1957 Strato-Flight reverse unit has been decreased, resulting in a larger reverse sun gear. The larger sun gear will not fit through the Clutch Unit Holding Fixture J-6116 when mounting the clutch unit in the fixture for disassembly or assembly.

To enable proper mounting of the unit, it is recommended that the hole in the Holding Fixture be enlarged by filing or grinding approximately 1/16", as indicated in Fig. 3.

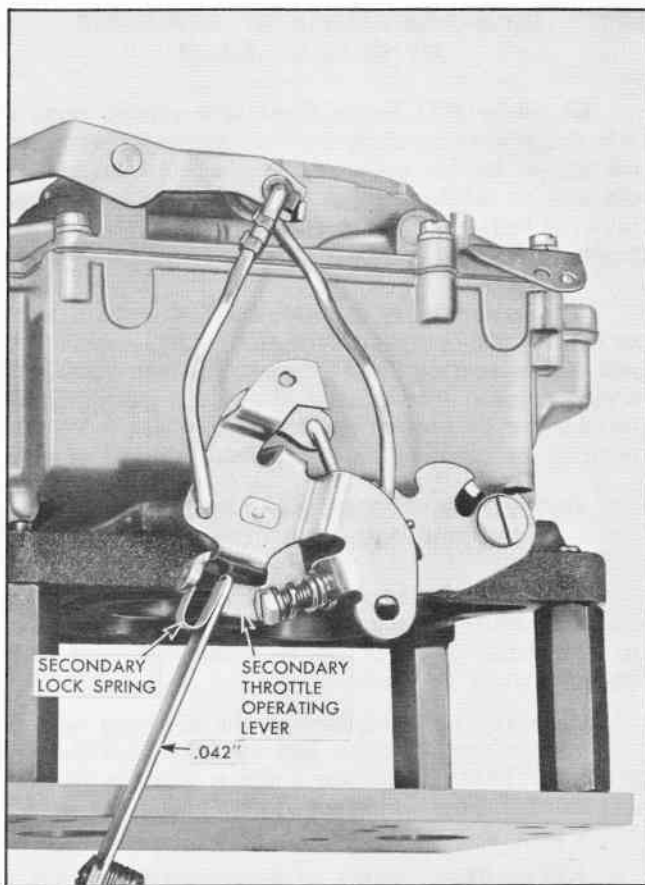
Fig. 4 Measuring Clearance Between Secondary Lock Spring and Secondary Throttle Operating Lever

Several cases of rough hot idle on the Rochester 4 GC carburetor have been traced to a sticking action of the secondary throttle valve. To eliminate this condition a carburetor adjustment has been released which will ensure a positive closing of the secondary throttle valve on idle. This adjustment establishes tension of the secondary lock spring (Fig. 4) against the secondary throttle operating lever, holding the secondary throttle valves closed. The adjustment will apply to all 1956 Rochester 4 GC carburetors as outlined below.

It is important that this adjustment be made accurately. .042" clearance ensures the proper amount of tension when car is on hot idle. Too much tension (less than .042" clearance) could interfere with the idle speed adjustment. Another possible cause for secondary throttle valve sticking was covered on page 48 of August, 1956 Service Craftsman News.

1. Adjust carburetor idle speed and mixture. (Be sure secondary valves are closed during this adjustment.)
2. Shut off engine and manually close choke valve.
3. Position idle speed screw on the second step of the fast idle cam.
4. Measure clearance between the secondary lock spring and the secondary throttle operating lever. This clearance should be .042". Bend lock spring to adjust.

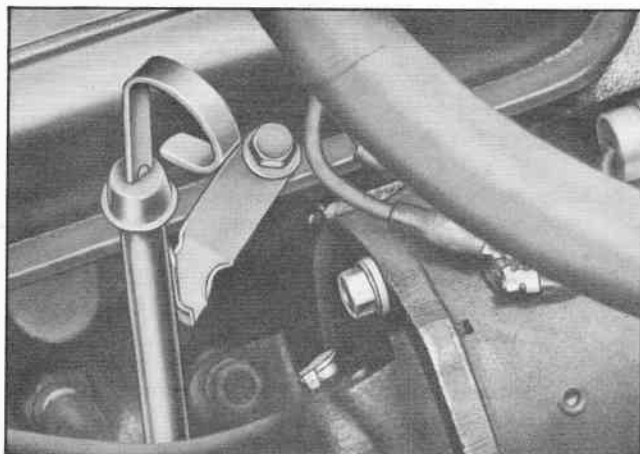
Fig. 5 Dip Stick Installed

Reports have been received of interference between the air conditioning compressor hoses and the crankcase oil level indicator when the indicator is removed to check engine oil level. Continual removal and replacement of the oil level indicator will eventually break the indicator.

On cars where this condition has occurred the oil level indicator tube assembly may be modified as follows to permit easy removal of the indicator.

1. Procure a piece of sheet metal 1/32" thick, 1-7/8" long, and 5/8" wide.
2. Drill two 3/8" holes 1 1/2" apart.
3. Remove oil level indicator upper tube assembly from engine, attach extension to upper tube assembly with a nut, lock washer, and bolt and replace upper tube assembly and extension.
