PONTIAC

Service Craftsman News

No. 10 S-288

November, 1956

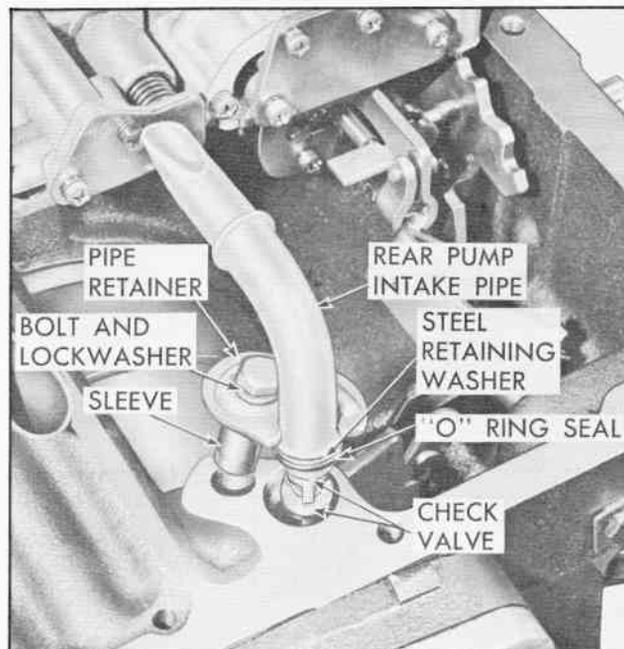
Fig. 1 Rear Pump Intake Pipe and Check Valve

NEW REAR INTAKE PIPE KIT REDUCES H.M. NOISE IN REVERSE

If an owner complains of a scraping noise heard when operating in reverse, there is a possibility that the noise originates in the Strato-Flight transmission. The noise generally is most pronounced when backing up in close quarters (garage, alley) or in a noise-free area. This is not harmful in any way to the transmission nor does it indicate damage within the transmission. It is the result of gear rotation in the rear pump under conditions when the rear pump is not supplying oil. The noise can be reduced, and may be completely eliminated, in some cases by installing a new rear pump intake pipe containing a check valve (Fig. 1). (The new Rear Pump Intake Pipe Kit is serviced under Part No. 8616978.) The check valve stops main line oil from exhausting through the rear pump when it is operated in reverse, thereby keeping oil pressure on the pump gears. The suggested straight time for installation of rear pump intake pipe is .8 hour.

1. Drain fluid, remove pan, and discard gasket.
2. Remove following parts from the transmission.
 - a. Rear pump intake pipe.
 - b. "O" ring seal
 - c. Oil Screen
3. Discard the pipe and the "O" ring seal.

4. Install bolt 1/2" into counterbored end of the sleeve. Then using bolt as driver install sleeve into canted hole adjacent to the rear pump intake hole, until the sleeve is flush with or up to 1/16" below the machined face of the case. NOTE: Canted hole is the one in which the reverse stationary cone lock key is located.
5. Remove the bolt from the sleeve.
6. Assemble the rear pump intake pipe and valve as follows:

- a. Install steel retaining washer on pump end of pipe.
 - b. Install new "O" ring seal next to retaining washer on pipe.
 - c. Install check valve into pump end of pipe.
7. Install pipe assembly into case.
 8. Install pipe retainer with the raised edge out and the open end of the retainer toward the rear of the transmission. Secure retainer with bolt and lock washer, torquing the bolt to 5-6 lbs. ft. **CAUTION:** Excessive tightening will pull sleeve out of hole.
 9. Install oil screen.
 10. Install oil pan using new gasket.
 11. Refill transmission with Hydra-Matic fluid.

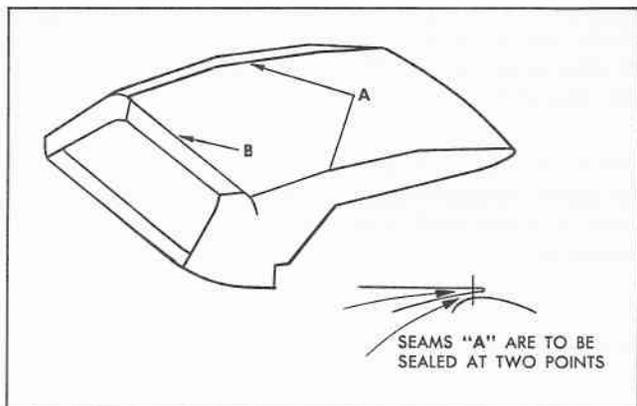
Fig. 4 Sealing Locations On Convertible Top

In order to prevent leakage at the seams of service replacement convertible tops, it is imperative that two sealing operations be performed. Three-M Super Weatherstrip Adhesive may be used to seal seams "A" and "B" (Fig. 4) in the following manner:

1. To gain access to the seams at "A", raise the top approximately half-way. Open the seam from the underside of the top and apply 3-M Super Weatherstrip Adhesive along the entire length of the seam with a plews oiler. Note that a double bead of sealer is required to seal the seam (Fig. 4). Apply the sealer so that it will flow around the stitches and provide a proper seal. These seams must be sealed prior to installation of the top.
2. The seal at "B" can be sealed from outside by removing the wire-on binding from the rear bow and applying 3-M Super Weatherstrip Adhesive along the edge of the tucked area. This operation can be performed immediately prior to installation of the wire-on binding.

Whenever water leaks are encountered at seams "A" and "B" on any Pontiac convertible top, it is recommended that they be sealed in the above manner.

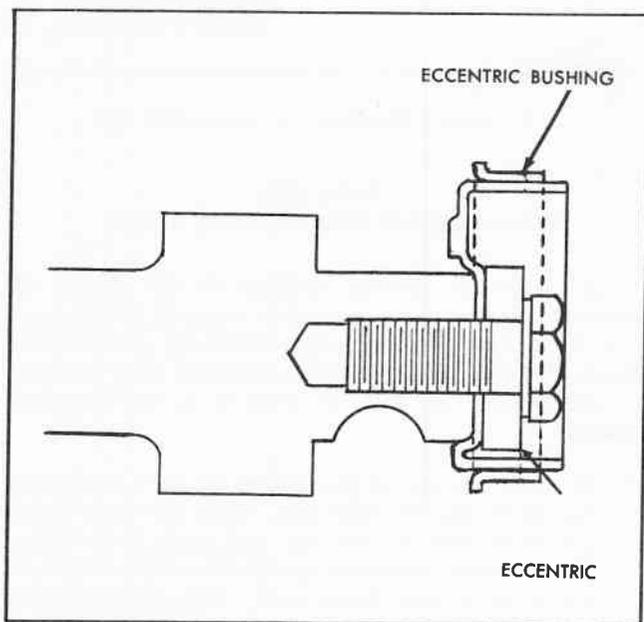
Fig. 6 1957 Fuel Pump Eccentric and Bushing

Beginning with 1957 model production a fuel pump eccentric bushing has been used in production. This bushing is positioned over the eccentric on the cam-

shaft with the flanged end toward the camshaft. Fig. 6 shows the bushing correctly installed. A clearance of approximately .010" exists between the bushing and eccentric.

The eccentric bushing has been released for service use under package number 523024. This package consists of a camshaft eccentric bushing and a camshaft eccentric.
