PONTIAC

Service Craftsman News

No. 11 S-289

December, 1956

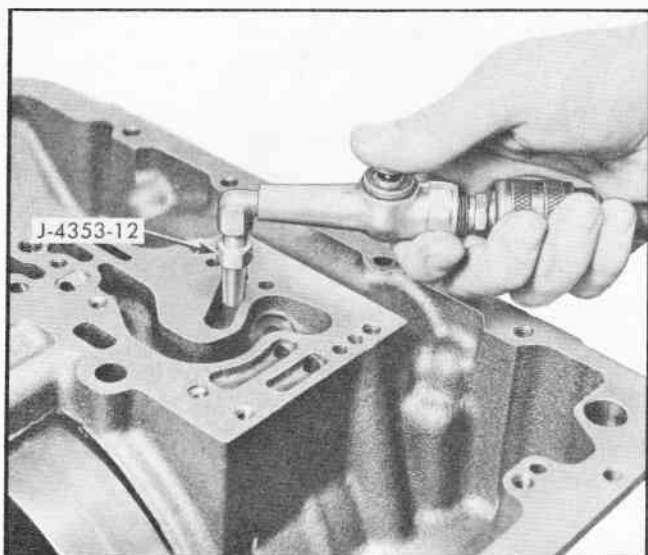
Fig. 1 Blow-Gun Adapter J-4353-12

A Blow-gun Adapter, J-4353-12, to be used with Blow-gun J-4353-3, is included in the 1957 Pontiac Essential Service Tools Package. This adapter is necessary to properly clean and check leaks in certain inaccessible oil passages (Fig. 1). However, it may be used on all oil passages in the 1956 and 1957 Strato-Flight and 1956 Dual Range Hydra-Matic transmissions.

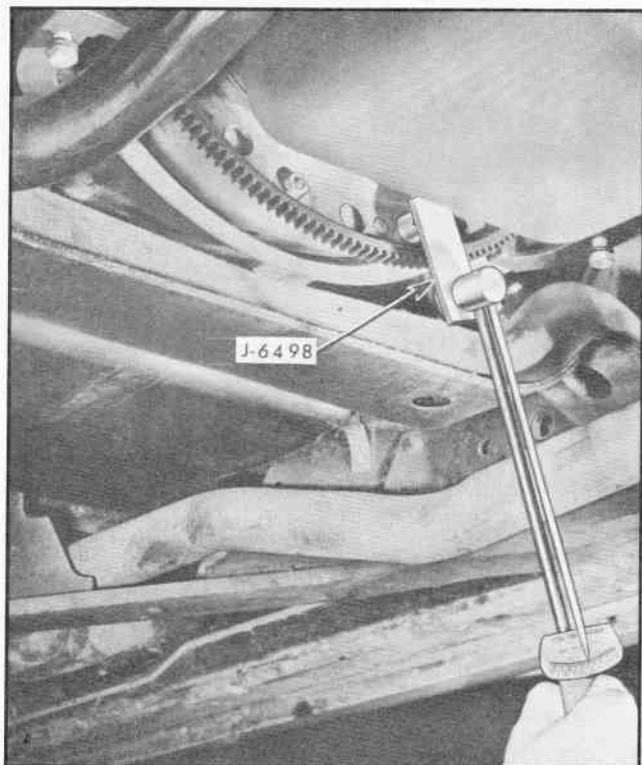
Fig. 2 Strato-Flight Torque Wrench Extension J-6498

The Strato-Flight Torque Wrench Extension is included in the 1957 Pontiac Essential Service Tools Package to aid in properly tightening the bolts which attach the flex plate to the torus cover and flywheel (Fig. 2). Because of insufficient clearance between the flex plate and the engine oil pan, a standard socket attached to a torque wrench cannot be used for this operation. The extension makes possible the use of a standard socket for tightening these bolts. This tool readily adapts the proper 3/8" socket to any 1/2" Drive Torque Wrench.

In order to prevent stripped bolts or damage to the flywheel or flex plate, a new torque specification of 15 lb. ft. has been established.

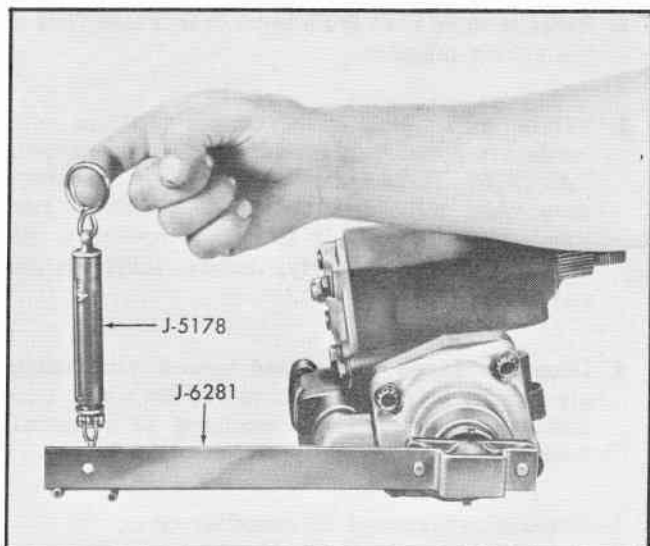
Fig. 3 Power Steering Over - Center
Adjusting Adapter J-6281

The power steering over-center adjusting adapter, J-6281, is to be used with spring scale J-5178 to make the adjustment of load through the center high point.

After the steering gear is completely assembled, find the center or straight-ahead position of the worm by rotating worm to full right turn and then reversing it approximately two full turns. Using adapter, J-6281, and spring scale, J-5178, to measure pull, (Fig. 3) adjust lash adjusting screw so pull on spring scale is between 1 1/4 to 1 3/4 lbs. through the center high point when rotating worm shaft through an arc of 30°. Tighten lash adjusting screw lock nut to 25-30 lb. ft. torque. Recheck preload after lock nut has been tightened.

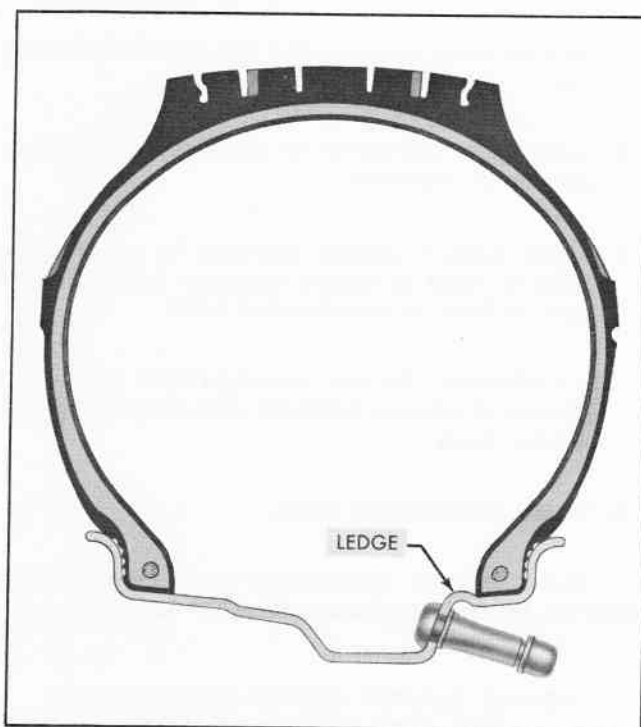
Fig. 4 Cross Section of Tubeless Tire and Rim

The 1957 wheel assembly has a ledge-type bead seat on the outboard (valve hole) side of the rim (see Fig. 4). This design provides a tight tire fit making it necessary to use a rubber lubricant such as Ru-Glyde or a vegetable oil soap solution for tire mounting and dismounting. This design also makes it mandatory that the tire mounting and dismounting are done with the outboard (valve hole) side of the wheel up.

1. Remove valve cap and valve core. Let out all the air.
2. With valve hole side of tire up break beads away from rim. Use only conventional bead-breaker type machine. Do not use hammer or tire irons.
3. Apply a liberal amount of lubricant and remove first bead, using machine method.
4. During the entire operation of breaking beads away from rim and removing tire from rim, special care should be taken not to damage the rubber "rim-seal" ridges which are molded to the outside of tire along the beads.

1. Using a small piece of steel wool or emery cloth, clean all particles of foreign matter from rim ledges and flanges.
2. Straighten the rim if it is bent or damaged.

1. Mount the tire on the wheel with valve hole side up using the machine method.

2. Remove valve core from stem to increase flow of air during inflation.
3. Inflate with wheel in horizontal position until beads are completely forced against rim flanges. **CATUION:** Do not exceed 40 pounds air pressure when inflating tire and do not stand over tire when inflating. If 40 pounds pressure will not seat beads properly, deflate, lubricate and re-inflate.
4. Once the beads are seated against rim flange, air can be released from valve, the valve core inserted and inflation completed in a normal fashion.
5. General precautions in mounting tires:
 - a. Use tire mounting and dismounting machine.
 - b. Do not use hammer or tire irons.
 - c. Work bead over rim flange so that the section nearest valve stem will be applied last.
 - d. Do not stand over tire when inflating.

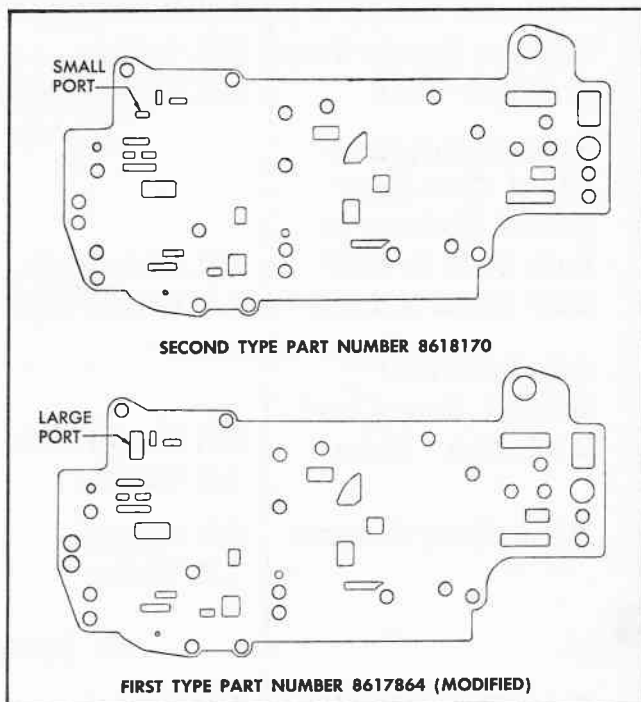
Fig. 5 Identification of Spacer-Channel Plate to Case

A change has been made in the 1957 Strato-Flight manual valve body and the channel plate-to-case spacer. The second type has a revised exhaust for neutral clutch apply oil in "Reverse". The difference between the first and second type 1957 channel plate-to-case spacers can be seen in Figure 5.

While the change in the manual valve body is difficult to recognize, the spacer plate can be identified to determine whether a control valve assembly has the first or second type manual valve body and spacer plate.

Only the second type parts will be serviced. The second type spacer plate can be used with either manual valve body. When installing a new manual valve body assembly, however, it is absolutely necessary that the second type spacer plate be used. The use of the second type manual valve body with the first type spacer would cause leakage of Lo Range oil resulting in failure of the Lo band.

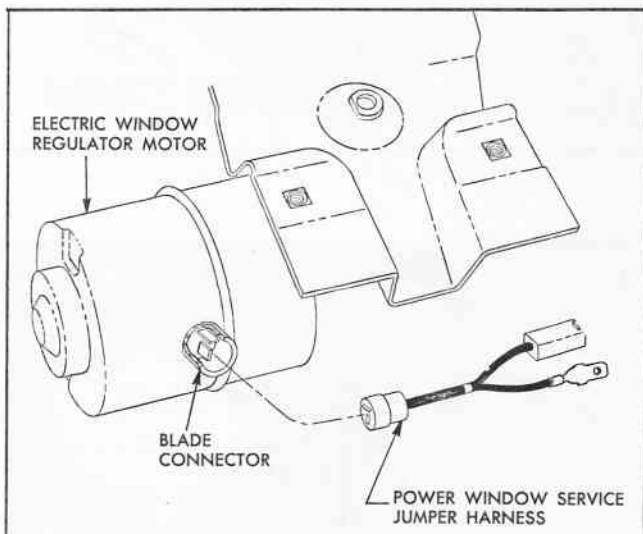
Fig. 7 Power Window Jumper Harness Assembly

The 1957 Electric Window Regulator Motor can be installed on 1955 and 1956 models by using a newly developed Power Window Service Jumper Harness Assembly, part number 4712588. The 1957 motor incorporates a new socket and blade type connector attached directly to the motor case (Fig. 7). The Power Window Service Jumper Harness is designed to engage this blade type connector on the 1957 motors and has the necessary terminal and connector for connecting with 1955 and 1956 body wiring harness (Fig. 7).

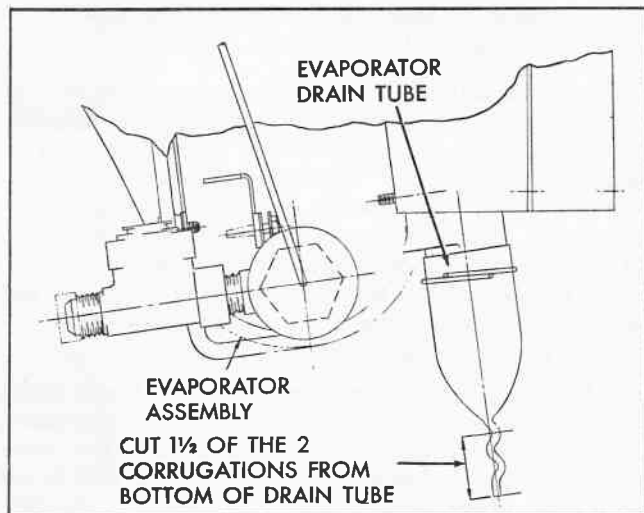
Fig. 8 Evaporator Drain Tube Modification

Under heavy rain conditions or when the car is being washed, the 1957 Air Conditioning Evaporator will not discharge water rapidly enough through the Evaporator Drain tube, with the result that water fills up the Evaporator and floods over into the Blower Housing and down the face of the Dash Insulator on the inside of the car.

To correct this condition, cut off one and one-half (1-1/2) of the two corrugations from the bottom of the Evaporator Drain Tube (Fig. 8). This modification should be made at the earliest opportunity to forestall the condition and prevent any owner dissatisfaction.

The tube may be removed from underneath the car. Straight time allowance to perform this operation is .2 Hr.
