PONTIAC

Service Craftsman News

No. 2 S-291

February, 1957

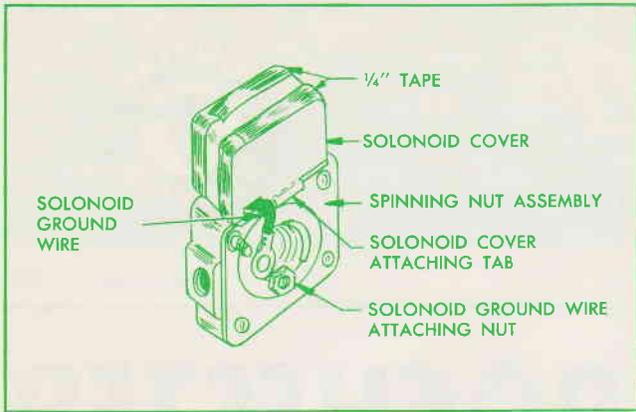
Fig. 1 Taping of Power Seat Solenoid Cover

We have received several field reports concerning loose solenoid covers on early production bodies equipped with power operated six-way seat assemblies. This condition can be corrected by first disconnecting the solenoid to spinning nut ground wire, straightening the solenoid cover attaching tabs; then wrapping three (3) or four (4) layers of 1/4" wide tape around the front and rear edge of the solenoid cover as shown in Fig. 1.

When the cover has been securely taped, carefully crimp the solenoid cover attaching tabs tight over the tape and secure ground wire with the attaching nut.

Changes have been made to correct this condition in production by using a specially designed clip to retain the solenoid cover.

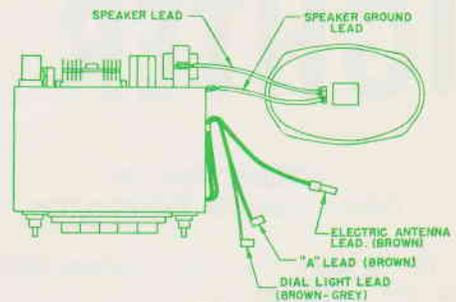
FIG. 14

We have found that the connections of the radio unit and speaker in the installation or re-installation of Pontiac radio Model #988671 has caused some confusion in the field resulting in speaker failures. The radio has three leads that may connect to the car and there are two leads from the speaker to the radio. The diagram below identifies these leads.

The "A" lead and dial light lead are a two wire "rip-cord" type cable and the dial light section of the lead has a gray strip. The electric antenna lead is a single lead with a plastic connector and is used only when the car has an electric antenna. The speaker leads are also in a "rip-cord" type cable. The signal lead has a green strip and plugs into a connector on the output transformer. The ground lead connects to a lance stamped from the radio case at the base of the output transformer.

Speakers can be damaged by incorrect connection of the speaker leads to the radio. The ground lead can be forced into the electric antenna lead and this places 12 volts D.C. on the voice coil of the speaker and ruins the speaker. This lead should connect to the ground lance on the radio case near the output transformer.

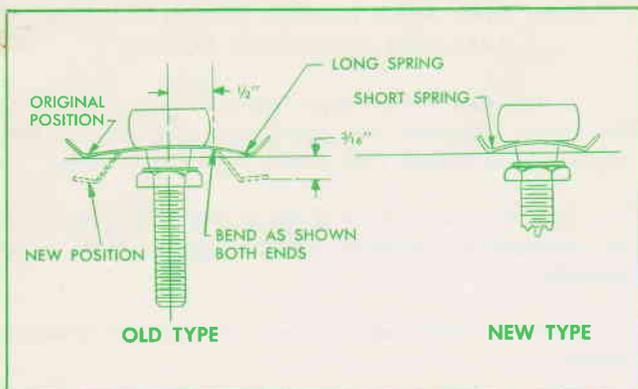
Fig. 2 Old and New Rear Door Guide Shoe Spring

If rear door window rattles are encountered on 4 Door Catalina bodies they may be due to insufficient tension of the rear door window center guide shoe against the center guide. The lack of tension is a result of the long center guide shoe spring (See Fig. 2) used in some early production 1957 bodies. This condition may be corrected by bending the spring, as indicated in Fig. 2, to increase the tension of the shoe against the guide. A shorter spring is now being used in production which will provide the required tension.
