PONTIAC

Service Craftsman News

No. 6 S-295

June, 1957

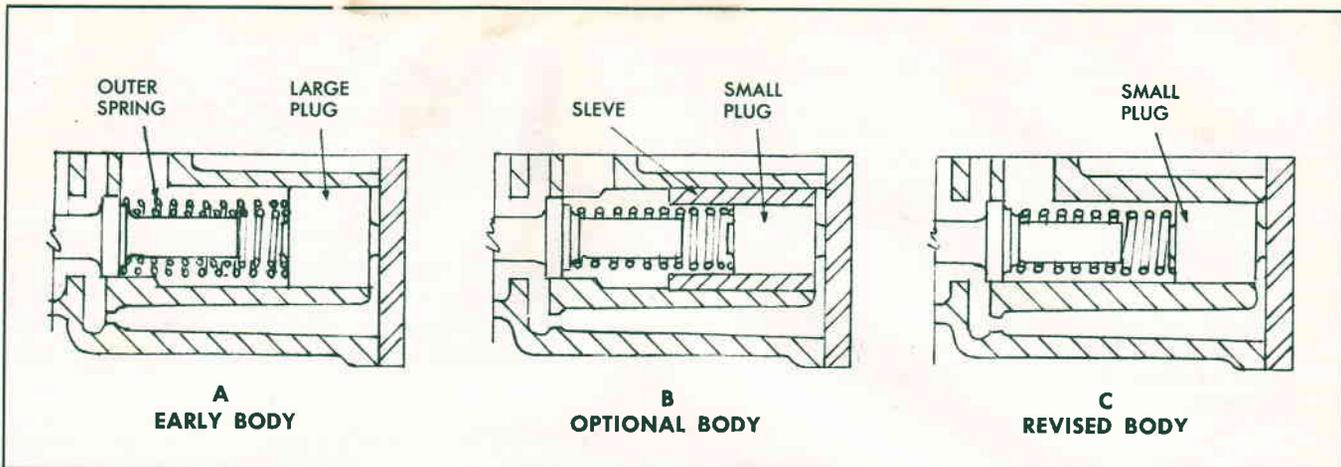
Fig. 2 Optional and Revised 1957 Clutch Valve Bodies

The clutch valve body in the 1957 Hydra-Matic transmission has been revised to provide a 2-1 detent downshift which will prevent engine "lugging" under extreme load at low car speed. The revised body directs 3-2 detent oil to the coupling valve (Fig. 1) to close the valve, causing a 2-1 downshift when the transmission is in second speed up to approximately 10 mph.

Coincident with this change and to prevent the possibility of an upshift in reverse, the coupling valve outer spring has been eliminated, and the coupling valve plug bore has been reduced to accommodate a smaller diameter plug.

In order to facilitate the above improvement, some transmissions were built using the early clutch valve body with a sleeve pressed into its bore and outer spring omitted, as shown in Fig. 2-"B".

Fig. 2-"A" illustrates the early design with inner and outer springs with the large diameter valve plug, Fig. 2-"B" is the optional or intermediate design, while Fig. 2-"C" shows the revised body with inner spring and smaller plug.

Channel plate, part No. 8618224 is used with the early clutch valve body Fig. 2-"A". Channel plate, part No. 8618195, is used with the optional and revised bodies (Fig. 2-"B" and 2-"C"). Channel plates are identified by a part number engraved in the panel on the plate.

Do not mix clutch valve bodies and channel plates.

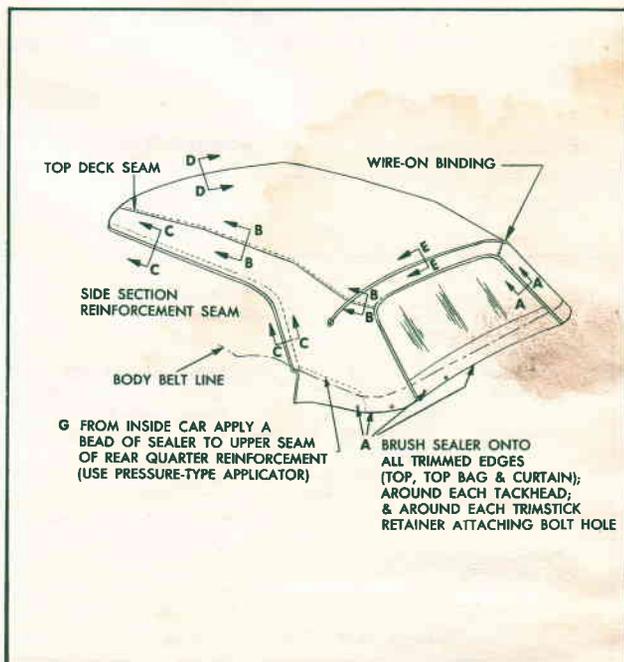
Fig. 3 Sealing Points on Convertible Top

Due to the inherent characteristics of a convertible top, a degree of water wicking has always been considered standard. In the event a convertible top is encountered with excessive water wicking stains, the stains may be removed and the wicking characteristics substantially reduced by using the materials and procedures given below.

Using a 1/2 inch wide bristle brush, apply sealer to: trimmed edges of top, top bag and back curtain; around each tack head; and around each trimstick retainer attaching bolt hole. See "A" in figure 3. If holes in top material are too large and/or improperly cut or punched, apply a liberal amount of 3M Super Weatherstrip Adhesive around the holes, then apply a section of waterproof industrial tape to outside of top material over the cemented area. Pierce or punch tape to allow trimstick retainer attaching bolts to slide through.

Using a pressure-type applicator, very carefully apply a bead of sealer to upper edge of folding top rear quarter reinforcement seam from inside car. See "G" in figure 3.
