PONTIAC

Service Craftsman News

No. 7 S-296

July, 1957

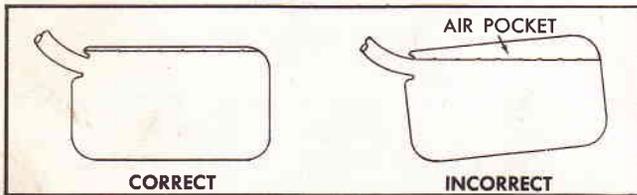
Fig. 1 Filling Fuel Tank

Fuel gauge readings should be made from the five marks on the face of the gauge, the left-hand dot indicating empty, the center dot half full and the right-hand dot full; the letters "E" and "F" point out direction of indicator travel only and are not fuel level marks. Always take reading directly in front of gauge.

The gauges are sensitive to voltage and temperature and are calibrated to give an accurate reading with the generator charging at 14.5 volts (engine running at fast idle) and car setting level. The reading can be as much as one-eighth of a tank off if taken with the engine not running or at slow idle with generator not charging. Also, the gauge indicator may drop half a needle width when the generator is charging at only 12.5 volts.

To fill tank to capacity, make sure car sets level and fill slowly to reduce air pocket since tank is not vented. (See Fig. 1) Do not bend float arm of tank unit to remedy low reading dash unit; this may result in quarter tank reading when tank is empty. If trouble actually exists, first determine if it is caused by one of the following: the dash unit, tank unit, the wiring or a faulty terminal connection.

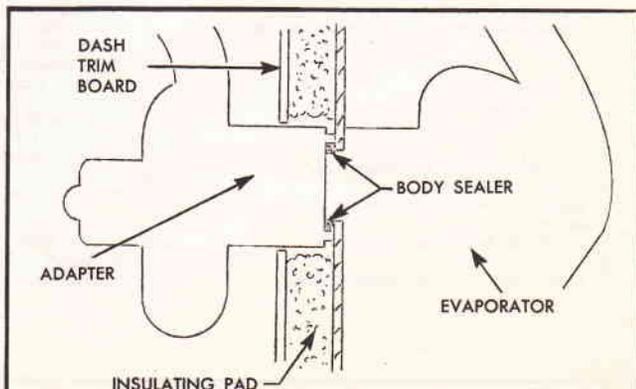
Fig. 2 Sealing Airconditioning Adapter

6. Reposition the paper door in the rancostat. With the compressor clutch and rancostat operating properly, warm air leaks between the evaporator core and rancostat capillary tube would cause the rancostat to keep its points closed calling for more cooling (because the warm air would expand the gas in the capillary tube to keep its points closed). Continuous operation of the com-

pressor would continue to reduce suction pressure. As the suction pressure lowers, the surface temperature of the evaporator core is lowered to a temperature below the freezing point of water. As the warm outside air loses its heat to the evaporator core surface, any moisture in the air is also deposited on this surface and will freeze to restrict air flow through the core.

- a. Tighten adapter to evaporator bolts.
- b. Using body sealer, reach inside blower to dash adapter and thoroughly seal joint (or space) between adapter and dash, (See Fig. 2) Note: The dash adapter has four (4) 1/16" legs at end of bolt holes which hold adapter from dash to compensate for any rough or irregular dash surface in this area. In some cases this air gap permits enough warm air to be pulled into air flow system to cause a "freeze-up" complaint.

- c. Place a bead of body sealer around front face of adapter to provide a seal between adapter and rancostat plate. Note: Do not place any body sealer in slot of adapter which is provided for rancostat capillary tube. This slot is in left side of adapter.

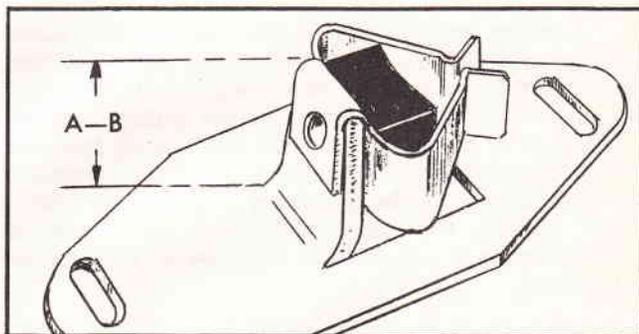
Fig. 3 Safari Rear Seat Back Retainer

The folding rear seat back on a two seat Safari is held in the "up" position by retainer assemblies on each side of the seat. Production Information Reports have been received stating that these retainers squeak and rattle. Investigation reveals that retainers on early production Safaris were too long (distance A-B, Fig. 3) causing them to rub against the cover.

If this condition is encountered, the retainer should be replaced with a current production part having the correct clip length, 55/64 inch. Lubricate the clip with DC #4 Compound (silicone) or glycerine.

After the new assembly is installed, check to see that there is enough clearance between the retainer and cover to prevent squeaks. Also, see that there is clearance between the stops on the sides of the seat back and the slots in the retainer covers. Retainer assemblies may be ordered under part Number 4650413.
