PONTIAC

Service Craftsman News

NO. 11 S-300

DECEMBER 1957

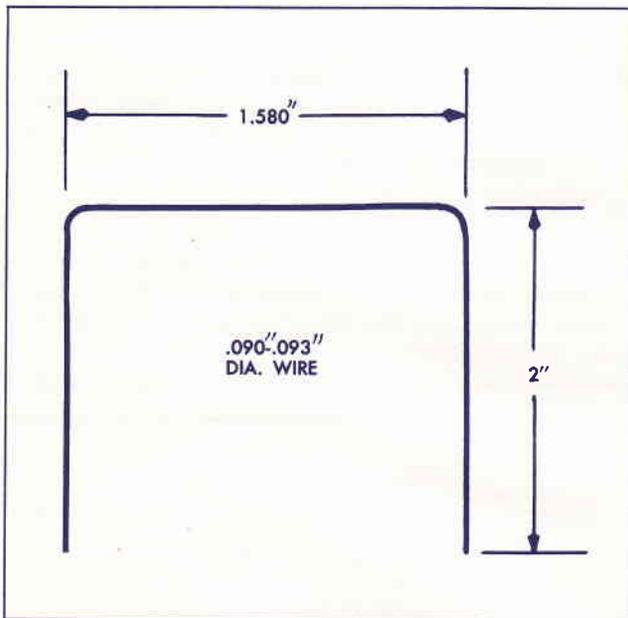
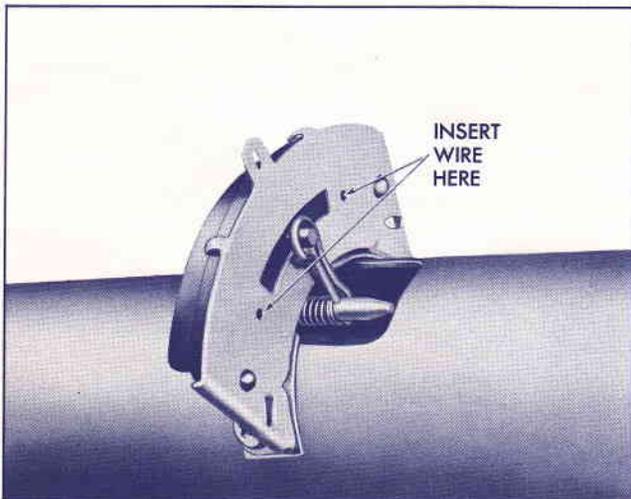
Fig. 2 Wire Gauge For Directional Signal Switch

Improper positioning of the directional signal switch has resulted in several cases of inoperative stop lamps. The directional signal switch is mounted in a slotted bracket and must be carefully centered on the steering column to ensure proper stop lamp and signal operation.

To positively position the switch a piece of .090" wire bent as shown in Fig. 2 can be used. The ends of the wire should be inserted in the two holes on the face of the switch (Fig. 3) before the attaching screws are tightened. If the switch is positioned so that the wire enters both holes freely, when in neutral position, it is centered correctly on the steering column.

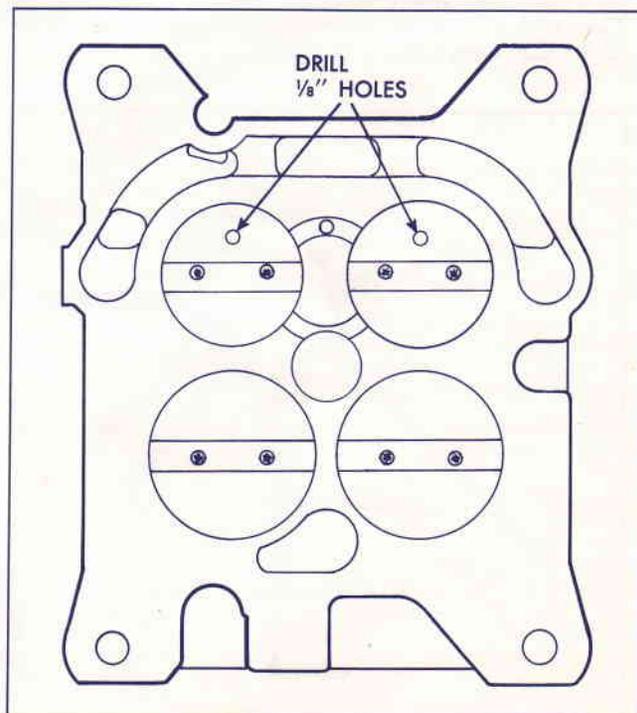
Fig. 8 Drill Holes In Primary Throttle Plates

A corrective procedure has been developed which will eliminate rough idle and stalling complaints caused by build-up of gum in the carburetor throttle bores. The correction, outlined below, consists of drilling a 1/8" hole in each primary throttle valve and performing the necessary idle adjustments. Care should be used when drilling to ensure no distortion of the throttle shaft. Center punching of valves before drilling should not be necessary.

1. Remove carburetor. Do not remove gum deposits from throttle bores.
2. Invert carburetor and drill a 1/8" diameter hole in each primary throttle plate as shown in Fig. 8. Do not drill secondary throttle plates.
3. Blow out any loose chips and re-install carburetor using new carburetor to manifold gasket.
4. Reconnect throttle linkage and adjust hot idle speed to 500 rpm in drive range.
5. Adjust carburetor throttle rod setting with gauge pin. It will usually be necessary to shorten throttle rod slightly to get correct adjustment.
6. Adjust mixture screws to give best quality idle.

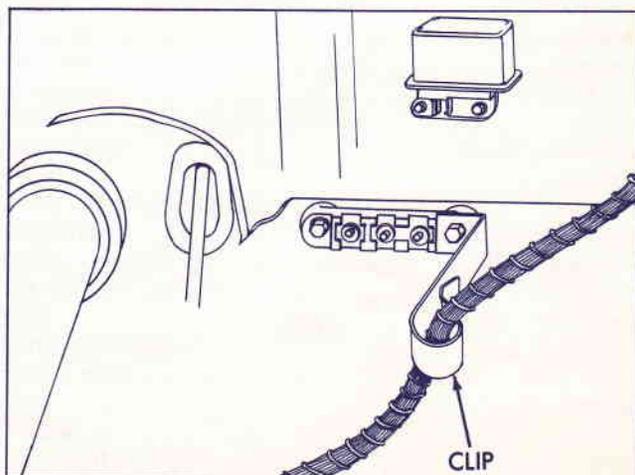
Fig. 12 Clip to Position Parking Brake Cable

On all 1958 Pontiac models built prior to November 5, 1957, there is a possibility of contact between the parking brake cable and the solenoid junction block terminals. This is the junction block mounted on the firewall level with and to the left of the steering column. Contact is most likely to occur as the brake is applied suddenly as this produces a "whipping" action of the cable.

Contact of cable with block will result in burning of the cable conduit and failure of the parking brake. To avoid any possibility of this occurrence a clip (part #530235), must be installed on all cars built prior to November 5. This clip is mounted on the outboard junction block screw as shown in Fig. 12. Replace present retaining screw with longer screw (part #3651216) or comparable screw. The end of the clip must be bent securely around the cable; however, no retaining screw is necessary.
