I talked to Troy on May 12 regarding a problem with the front end lower inner control arm shafts for a 1956 Pontiac. Reference Invoice# K26932, Order number K70221 5, dated 3/14/05.

Enclosed with this letter are two lower control arm shafts. These are being returned as defective.

## Current Problems.

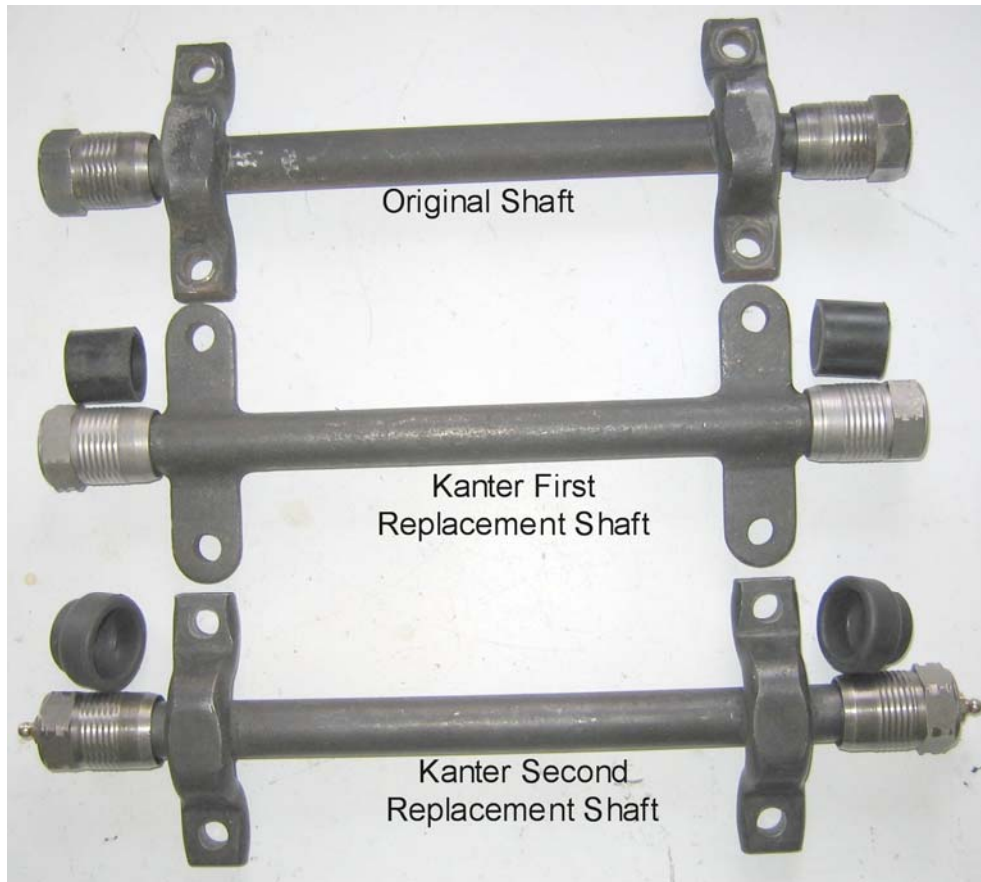
Below is a picture of three shafts, an original removed from my car and the two control arm shafts delivered by Kanter, one of the first replacement shafts and the second replacement shaft.

1. The first and second replacement shafts are quite different. The second replacement shaft looks almost identical to the original shaft (nice!) but the first replacement shaft looks quite different. This is unacceptable for quality restoration of an original car.

2. In the picture, all the bushings are screwed all the way down onto the shafts. Note on the second replacement shaft that the right bushing does not screw down nearly as far as the left bushing (because of defective threads).

3. The first replacement shaft will work. However, there is considerably more play in the bushings on the shaft than on the second replacement shaft. The bushings on the second shaft feel like they fit well with little play. For this reason and because the first shaft looks much different, I'm returning the first shaft along with the defective second shaft for replacement.

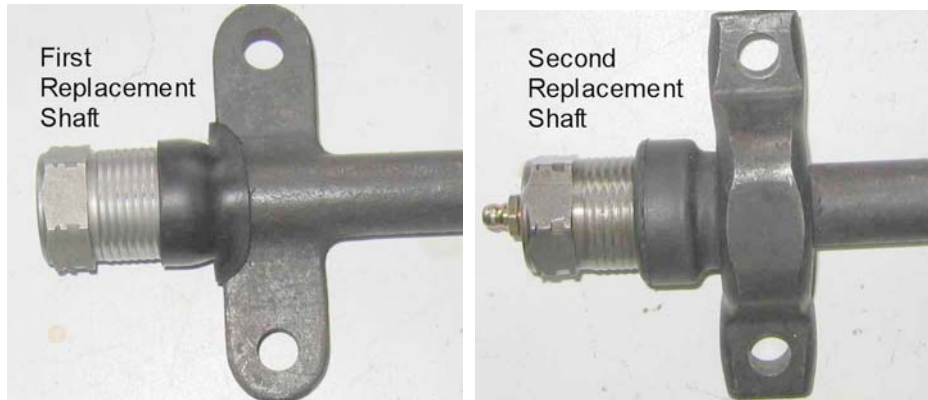
4. Note the very different rubber seals for the first and second replacement shafts. In the following picture, the seals are installed and the bushings screwed down onto the shafts. The seal on the first replacement shaft seems "Mickey Mouse" and cheap compared to the other.

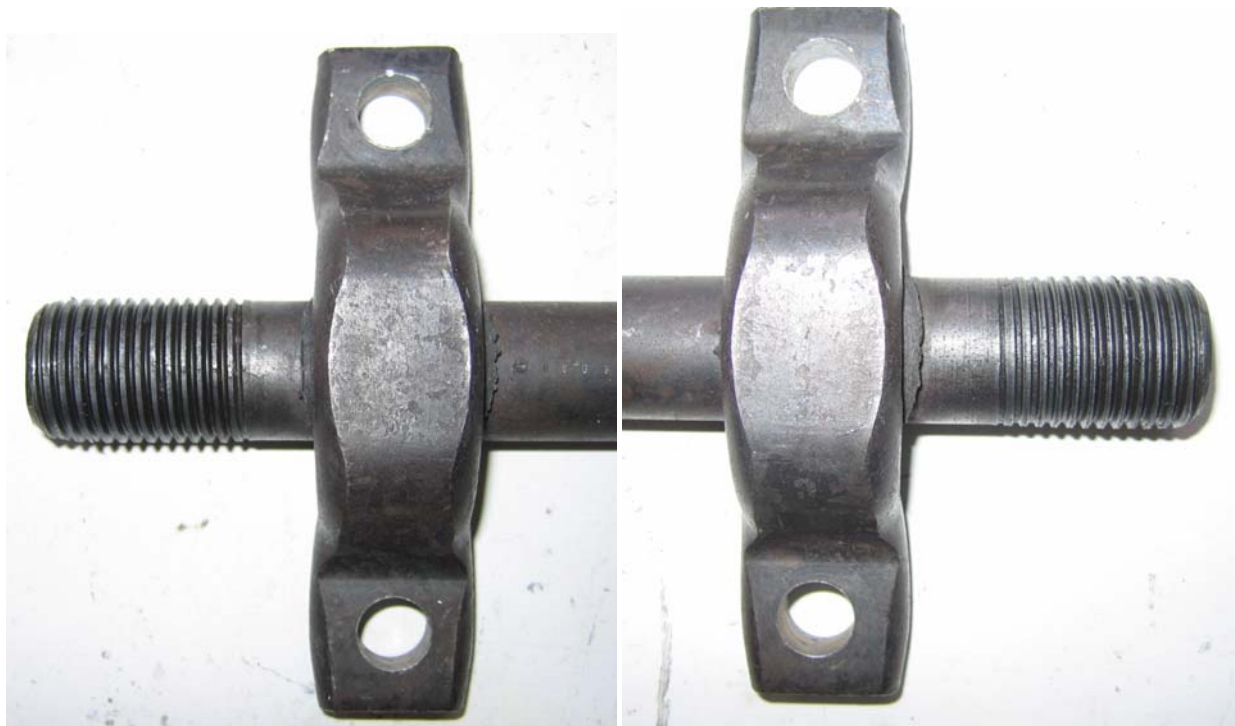
The picture below shows the threads on each end of the second replacement shaft.

The threads on the left end look good and feel good when the bushing is screwed down onto it. But note that the last few threads (threads nearest the center) on the right side are not cut as deep as the initial threads and are not cut as far down on the shaft. This is what prevents the right bushing from screwing down as far as it should. This is the shaft that Troy said he personally checked.
