# King Pins

By West Peterson / Photos by the author

Once the tie rod ends were replaced on our 1940 Packard Super 8 (see July/August issue), we proceeded to replace the king pins. The need to tackle these two jobs came about while we were changing the car's oil. After 45 years sitting in a museum, we were curious about what all might need to be done before turning this 50,000-mile car loose on the highway. The horizontal play in the front wheels revealed the need to replace the tie rod ends, while vertical movement told us that

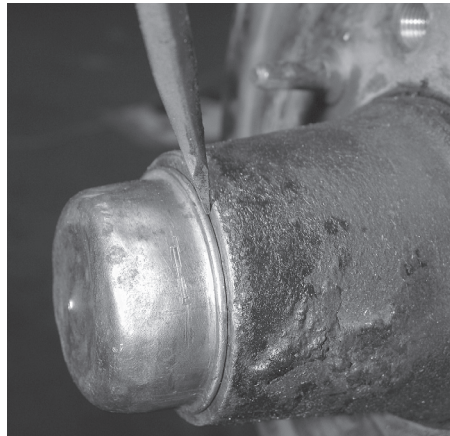
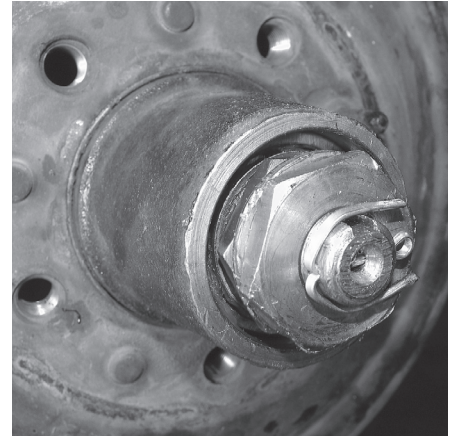
Assuming that everyone knows how to remove a wheel, we'll jump right into pulling the hub apart. Removing this little grease cap merely entails wedging a screwdriver between the hub and the cap and prying it off. Wrapping a channel locks around it and twisting back and forth will work as well, but you need to be careful not to crush it.

Behind the cap is a nut, a washer with an inner tab and alignment holes, and another nut with a button that locks into one of the washer's holes and helps secure everything in place. Once the nuts and washer are removed, the bearing will easily pull out. Now the brake drum is ready to be removed.

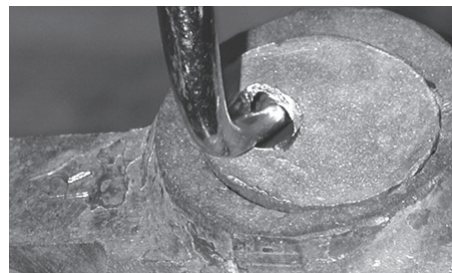
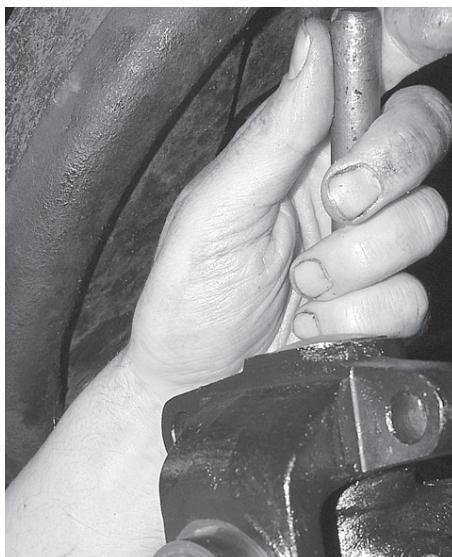
However, this car had a recent brake job performed and there was no need to upset a job we felt was done well. The four bolts holding the backing plate on need to come off first. There are castle nuts and cotter pins on the reverse side, which also hold the spindle arm to the backing plate).

Since the flexible hydraulic brake lines were still connected, the brake assembly needed to be secured so the brakes lines weren't supporting its weight. We used a coat hanger and hung the brakes from a fender brace.

With the axle spindle and king pin assembly revealed, we began to extract the worn king pins. The elements include the horizontal lock pin (A), the upper and lower end caps (B), the thrust bearing (C), spacer (D) and the king pin itself.

The way to remove the upper end cap is to drill a hole in it, and pry it off.

The lock pin must then be driven out, before the king pin can be driven out. Note: The lock pin bores are tapered, and are removed through the back on the right side of the car (passenger side) and through the front on the left.

While tapping the king pin out of the axle bore, the lower end cap will come out at the same time.

Once the king pin has been extracted, the spindle can be removed from the king pin assembly.

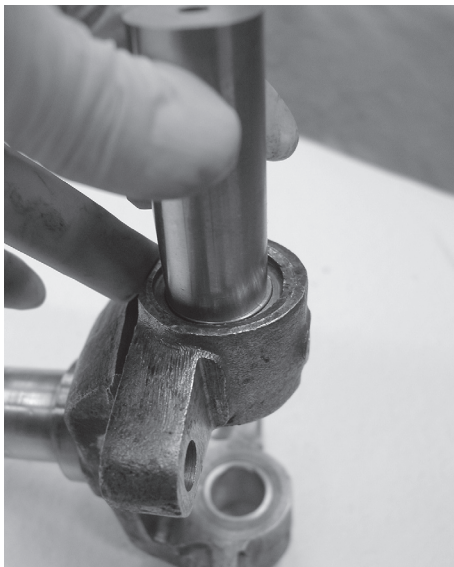
This tool, supplied with the new king pins, was used to drive out the old brass bushings from the axle bore. We sent the new set of brass bushings to a shop and had them pressed into place.

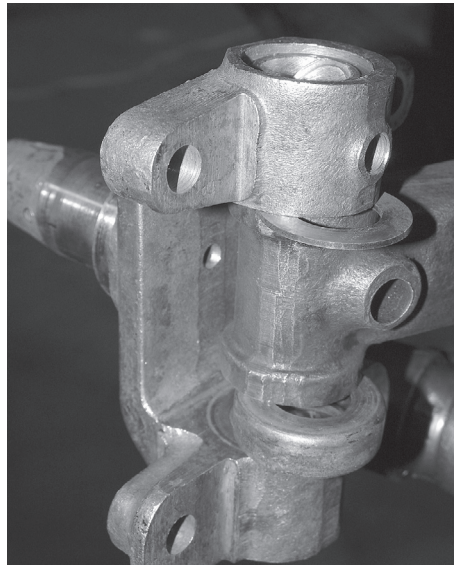
Reaming them to proper size afterwards was also done professionally. This is not difficult work if you've got the proper equipment, but not everyone has these types of tools at their disposal. Here we see the bushings being reamed, and the new king pin being set into place to check for proper fit. The proper fit should allow for swivel with around five pounds of torque applied.

With the bushings in place, we were ready to re-assemble. Here, all the new parts are ready to install, including new bushings pressed in place, king pins (notched where the new lock pin will hold it into place), spacers, thrust bearings, grease fittings and end caps.

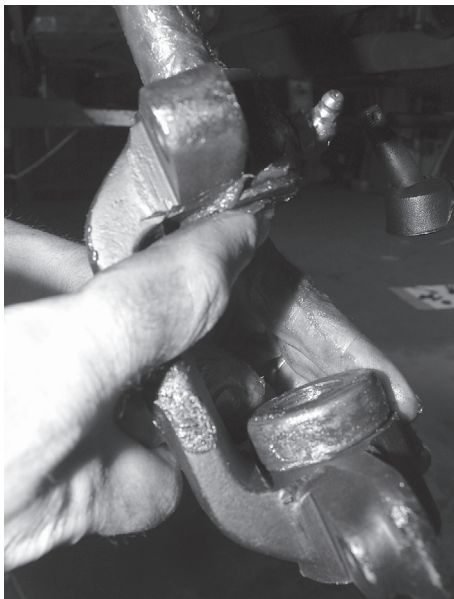
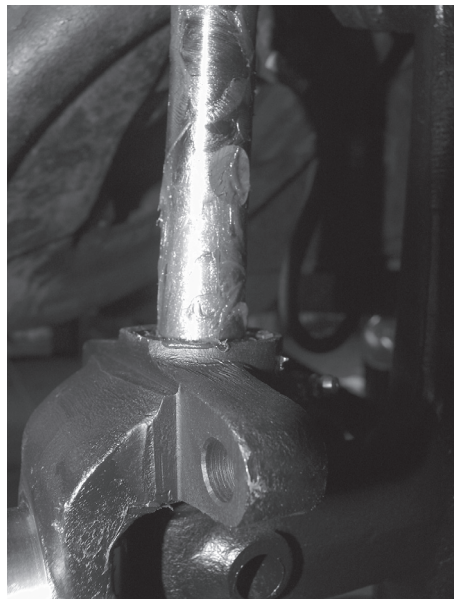
We did a "dry run" with all the new pieces. The new thrust bearing was a little taller than the old and would not allow for proper fit, and the new spacers were not properly sized either. Because the old bearing and spacers were perfectly good, we decided to reuse them. From this point on, cleanliness is important.

We liberally applied grease to the old thrust bearing and spacer, which held them into place. We also greased up the king pin itself, before we carefully tapped it into place through the axle spindle, carefully aligning the notch into position with the lock-pin bore.

With the notched king pin aligned perfectly, we tapped the new lock pin in securely. Remember, the bore is tapered and we're driving it in opposite the way we drove it out.

At this point, tap in the new end caps. We found it easier to install the bottom end cap before starting the re-assembly process.

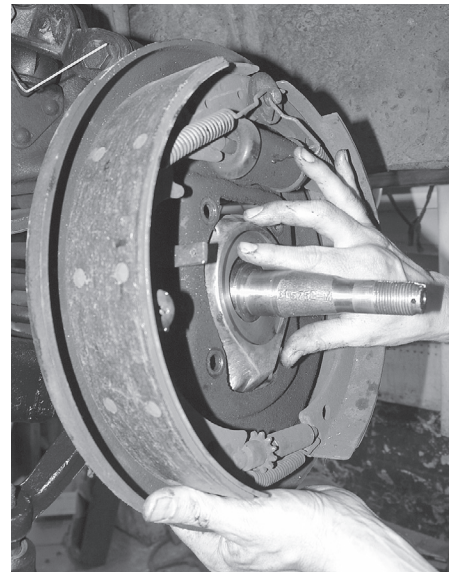
Putting it back together is little more than putting the pieces back the same way in which they came off. Here we replace the complete brake assembly.

Before we replaced the brake drum, we elected to repack both the inner and outer wheel bearings. The outer bearing set came out before the drum was removed. The inner bearings need to be tapped out from the inside of the drum. The wheel bearing seal will drop out at the same time.

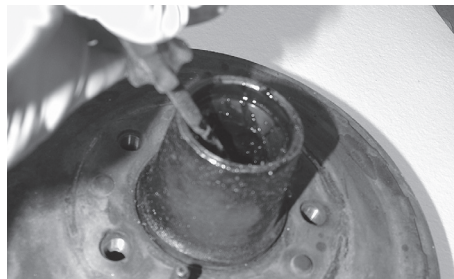
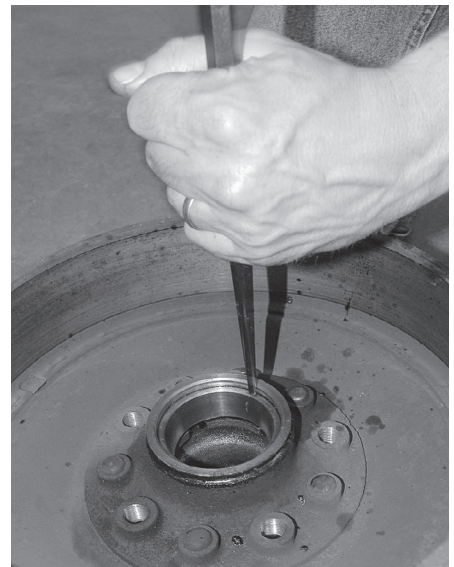
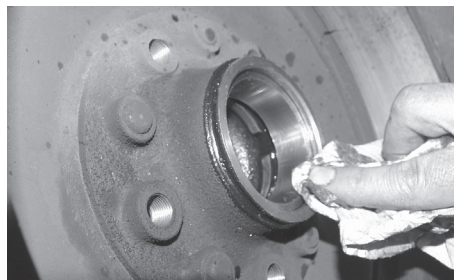
After cleaning and checking the bearing race (the bearing contact surface pressed into the hub) for wear or burn marks (blueing of the metal) and finding them okay, we lightly tapped it, alternating from side to side, back toward the outside of the hub.

Thoroughly clean the bearings in solvent and then blow dry with compressed air. Never spin the bearings with compressed air, doing so runs the risk of nicking the rollers. To pack them, put a wad of appropriate high-temp axle grease in the palm of your CLEAN hand and push the bearing through it several times, as shown. Work the grease through the bearing rollers, and continue until it oozes out the other side.

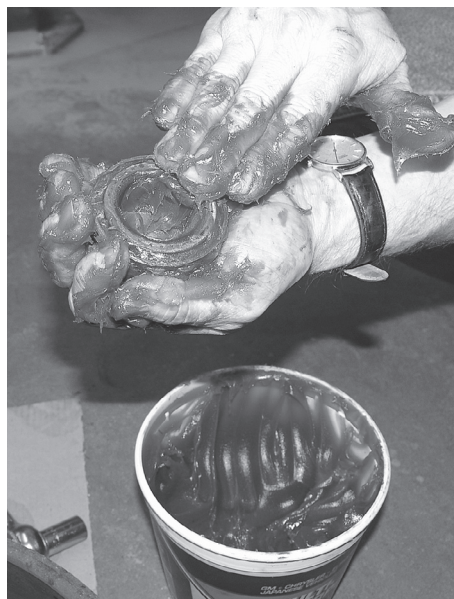
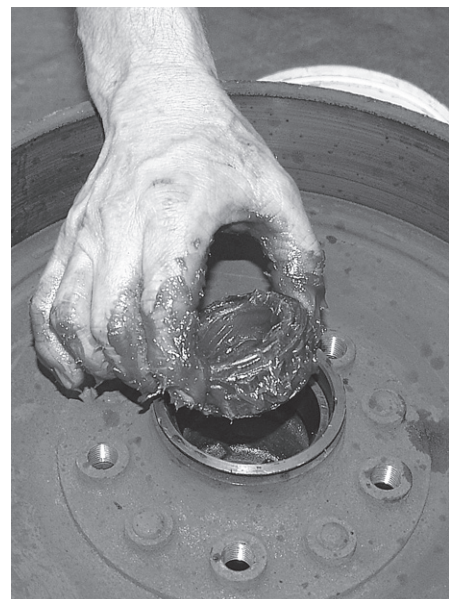
Drop the inner bearing back into place, narrow end of taper first.
