Curing LIFTGATE woes

So your Nomad's liftgate leaks. Don't feel like the Lone Ranger. That problem has plagued Nomad owners from the time the cars were new.

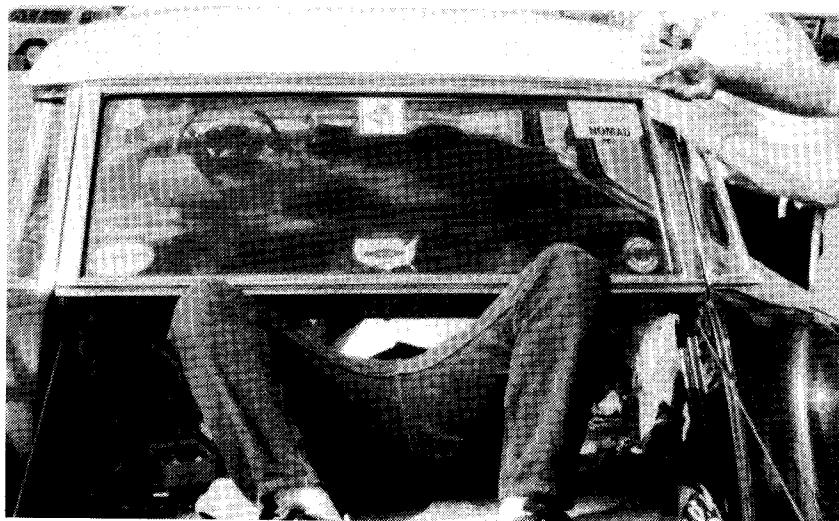
According to liftgate straightening expert Jerry Cabunoc, two common practices caused the liftgates to warp. First of all, owners would usually lift the 'gate in the middle. Then they drove with the 'gate open, whether for ventilation or carrying cargo. Not knowing any better,

they ended up with warped liftgates before they understood what caused the problem. While helping the owner raise the liftgate, over years of use the torsion bars also contribute to twisting the top of the frame upward in the middle and flattening the arc, Jerry says.

If your liftgate fits well, follow the advice Jerry gives owners after he's finished returning their 'gates to original straightness:

1. Remove the torsion bars and leave them out.

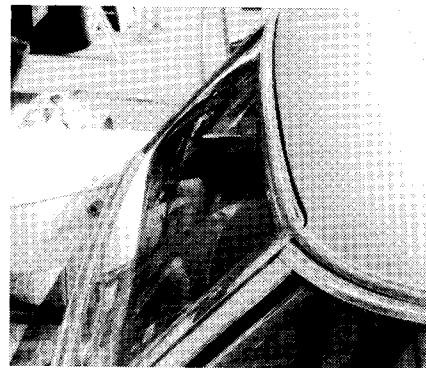
On Frank Carlson's '56 Jerry points out how the torsion bars have contributed to taking the arc out of the top rail to leave a water-catching gap. At right, it's bowed back into shape and, with new weatherstripping, should be water-tight.

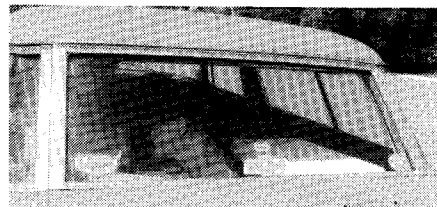
Top bar of the liftgate is usually spread upward in the center, pulling away from the glass seal rubber. After the Cabunoc treatment, it's back to square, matching the glass.

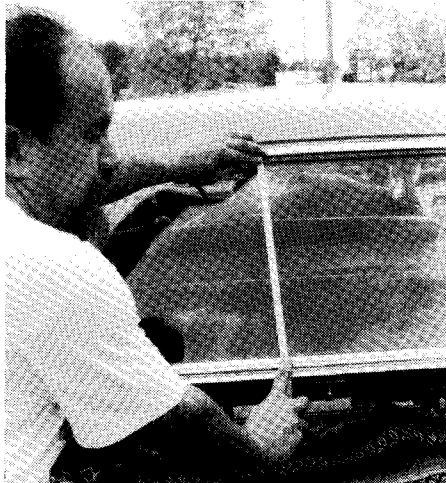
Measure the glass opening in the middle. It should be 15-3/4", the same as at the outer edges.

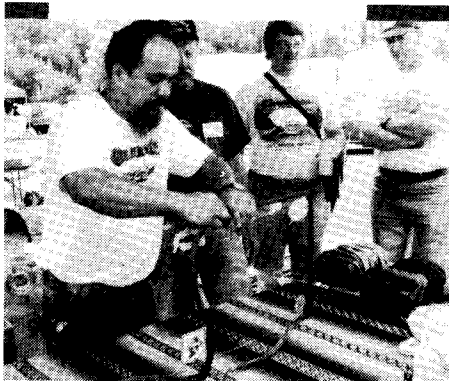
Install new rubber on the glass.

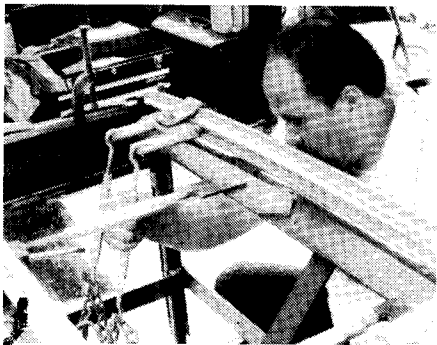
Steel plates attach to the top bar of the frame. Then Jerry attaches turnbuckles and tightens them to remove the twist in the top bar. He uses a gauge to determine when it's back to original straightness.

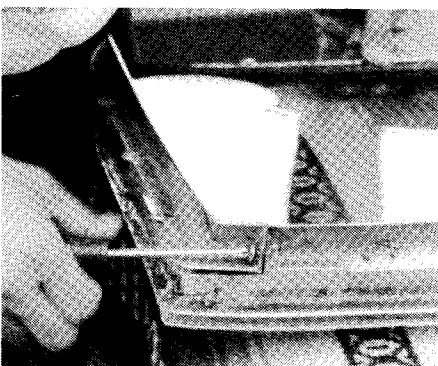
Screw the frame ends back into place.
