News Flash

No. 55-29

October 17, 1955

ATTENTION: DEALER SERVICE MANAGER

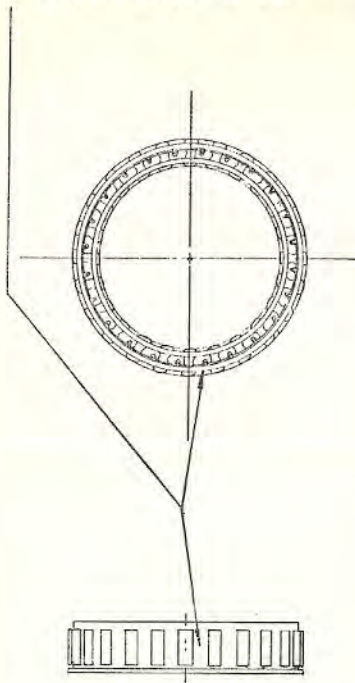
**LOCATION
SPRAG IDENTIFICATION
LETTER BW or ND**

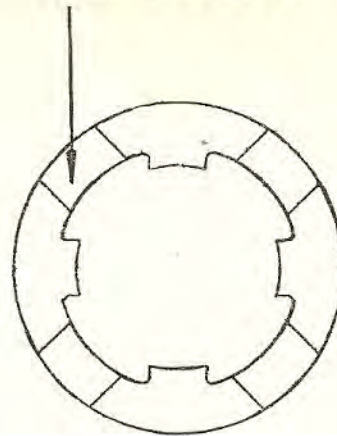
**LOCATION
INNER RACE IDENTIFICATION
LETTER O or S**

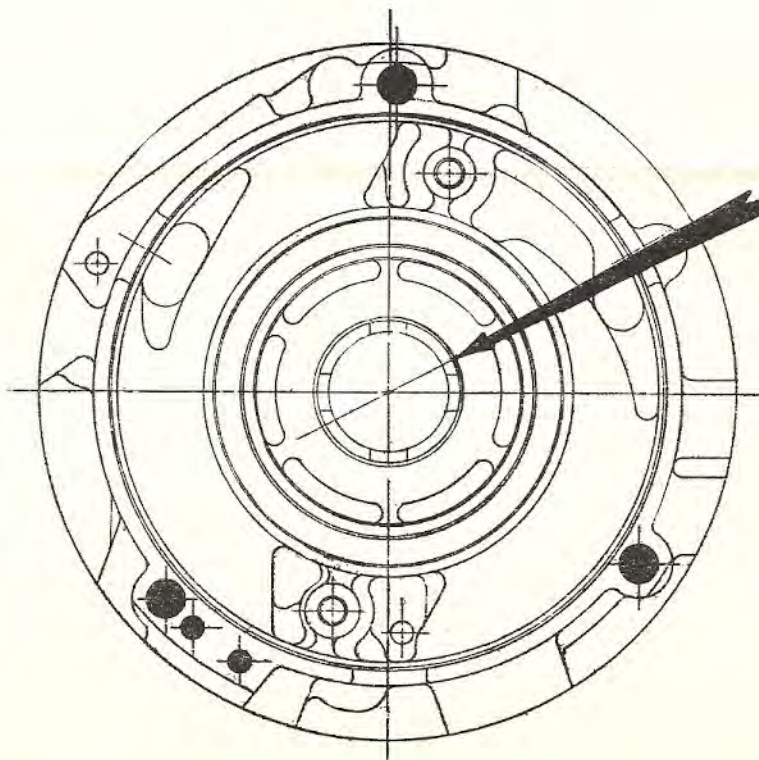
The clearance between the front unit driven torus shaft and the front pump bushing must not exceed $.003''$ using a $1/2''$ feeler gauge as shown in Fig. 3.

**LOCATION FOR TAKING MEASUREMENT OF CLEARANCE
BETWEEN FRONT UNIT DRIVEN TORUS SHAFT AND FRONT PUMP BUSHING**

**INSERT 1/2" FEELER
TO CHECK CLEARANCE
AT THIS POINT**

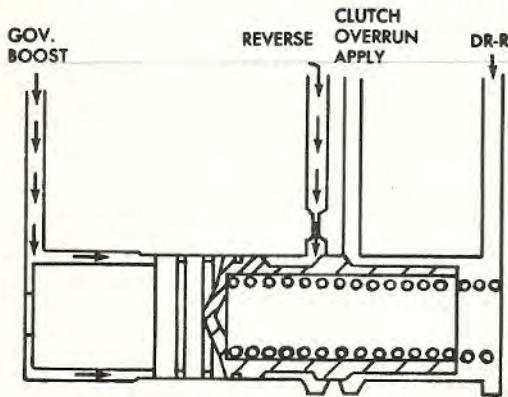
Fig. 1 Overrun Clutch Valve - Below 5 MPH

The overrun clutch valve is now controlled by governor boost pressure on one end working against a spring at the other end. At speeds under approximately 5 MPH the spring holds the valve to the left cutting off reverse oil to the overrun clutch (Fig. 1). Eliminating the overrun clutch application prevents starvation of the reverse clutch when shifting to reverse since it is not necessary to fill the relatively large volume behind the overrun clutch piston. A much firmer reverse clutch application results, which eliminates the grunt which was previously noticed in some transmissions. At speeds above 5 MPH the overrun clutch valve moves to the right to allow application of the overrun clutch (Fig. 2)

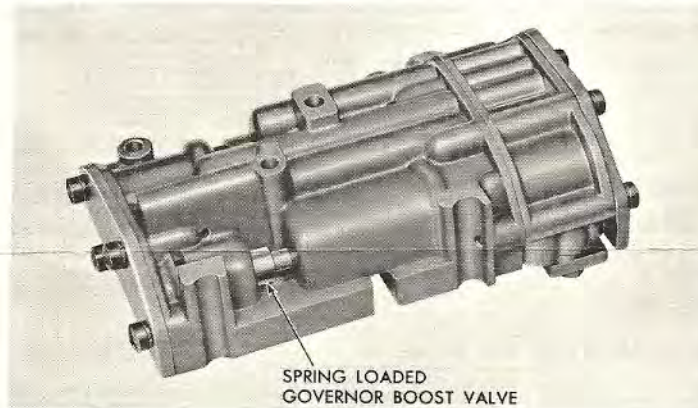
Fig. 3 Late Type Shift Valve Body

Service parts can be identified by the part numbers listed above. Visual inspection of the shift valve body on the transmission will show whether it is the 2nd type (with spring) or the 1st type (no spring). The valve will appear as shown in Fig. 3 on the 2nd type and the spring tension can be felt. On the 1st type the valve may or may not be visible, but it will be obvious that there is no spring tension.

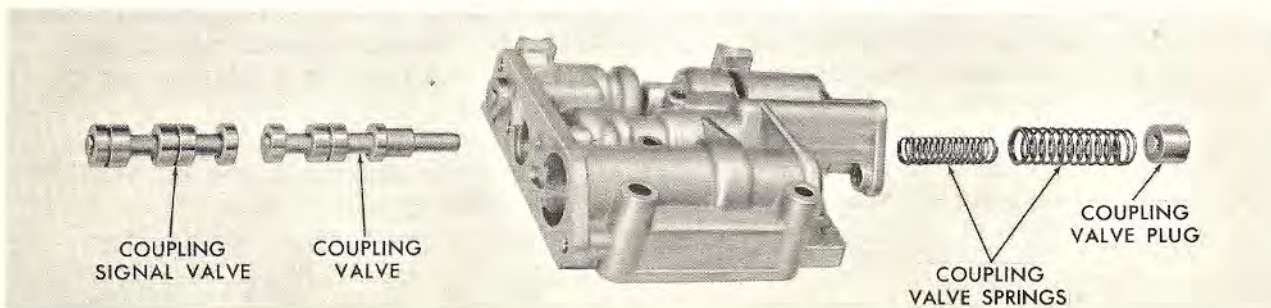
Fig. 4 Late Type Coupling Valve and Springs

When it has been determined which type shift valve body is on a control valve assembly, it can be assumed that the overrun clutch valve body is of the same type. If necessary to determine the type of overrun clutch valve body, the only method is by removing the rear plate which compresses the limit valve springs. It can then be determined whether the coupling valve plug is the 2nd type and whether there are one or two coupling valve springs (Fig. 4).

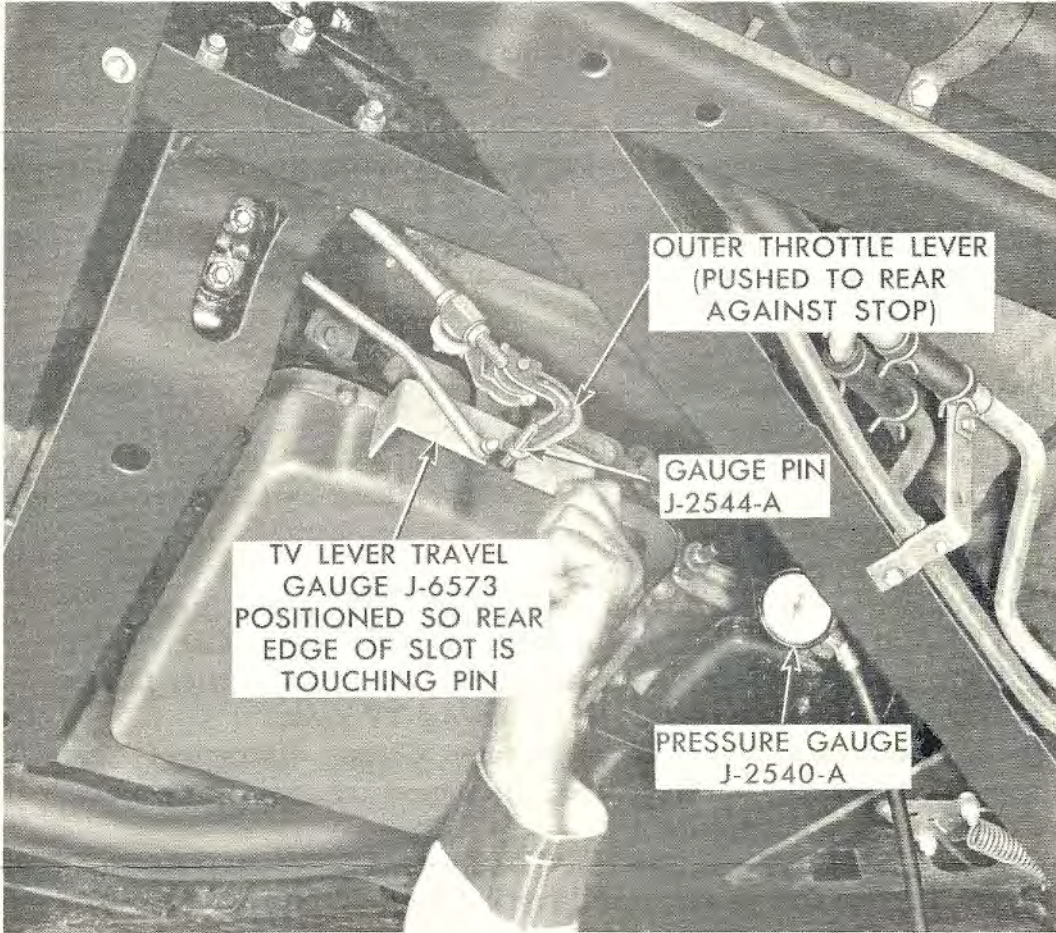
OUTER THROTTLE LEVER
(PUSHED TO REAR
AGAINST STOP)

GAUGE PIN
J-2544-A

12. Adjust throttle control linkage, setting the transmission throttle rod at "two turns short", as outlined on Page #39 in Part I of the 1956 Hydra-Matic Manual.
