# PONTIAC

## Service Craftsman News

No. 4 S-271

April, 1955

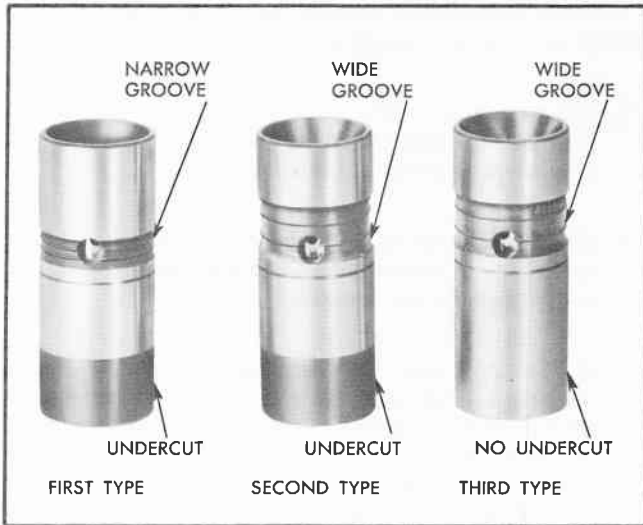
Fig. 3 Comparison of Three Valve Lifter Types

Since the beginning of production three type valve lifters, which differ in appearance, have been used. These three types are shown in Fig. 3. The first type has a narrow-groove and an undercut, the second type a wide groove and an undercut and the third type a wide groove with no undercut. These three types are interchangeable in all respects and are serviced under the same part number.
