# PONTIAC

## Service Craftsman News

No. 8 S-286

August, 1956

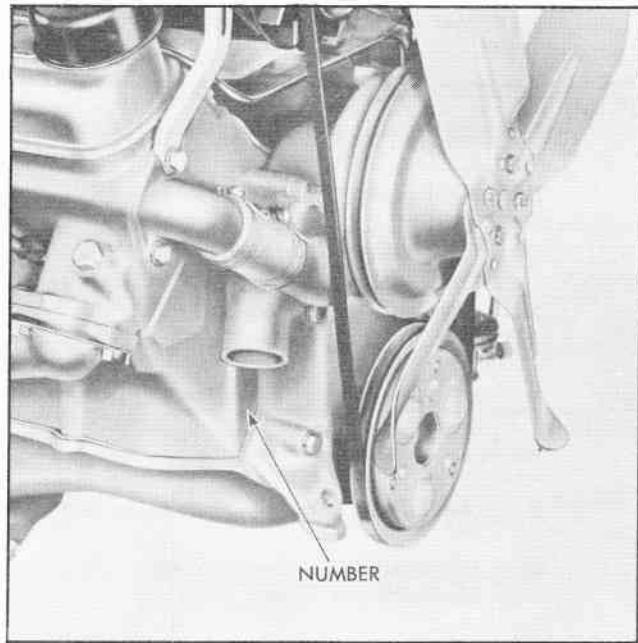
Fig. 7 Location of Production Engine Number

Fig. 7 shows the location of this number. To read with the engine in the car, it is necessary to use a mirror and light.
