PONTIAC

Service Craftsman News

No. 10 S-288

November, 1956

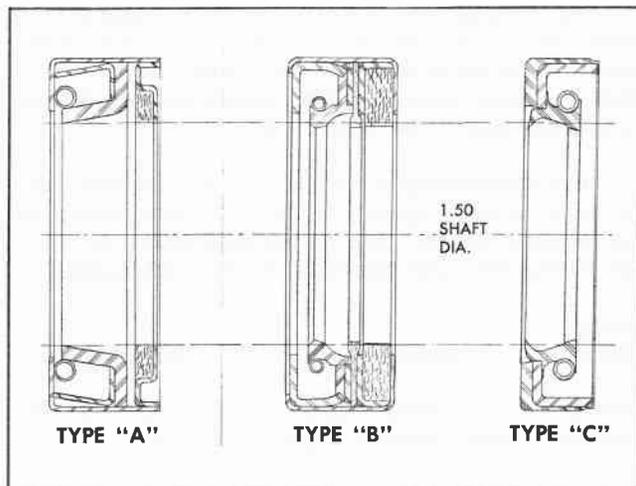
Fig. 5 Three Types of H.M. Rear Bearing Oil Seals

Three sources of rear bearing oil seals, Part No. 8612229 are utilized for servicing 1951 - 1955 Hydra-Matic transmissions. These seals differ in construction and appearance as shown in Fig. 5, but they are completely interchangeable. Be sure to lubricate rubber portions of seal with Lithium Soap Grease when it is installed.
