PONTIAC

Service Craftsman News

No. 7 S-296

July, 1957

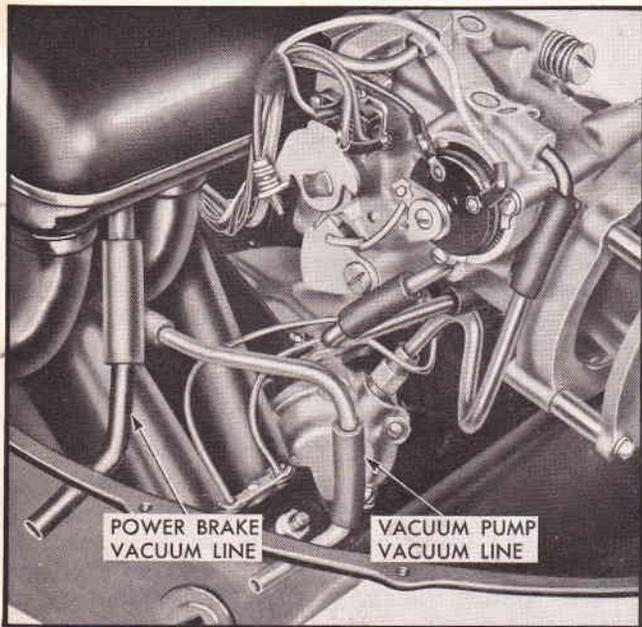
Fig. 5 Corrected Fig. 27 and 55 in Fuel Injection Manual

Fig. 27 and 55 show an incorrect location of the signal modifier and enrichment vacuum lines. Fig. 5 is a corrected illustration. Please correct your manuals accordingly.
