PONTIAC

Service Craftsman News

NO. 11 S-300

DECEMBER 1957

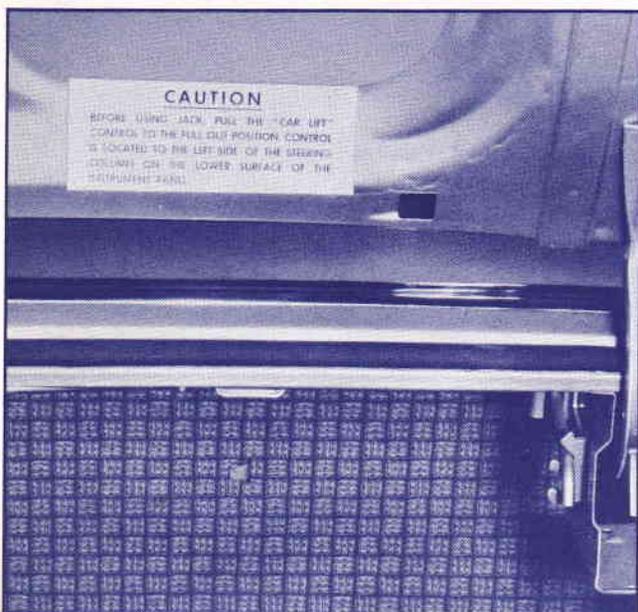
Fig. 1 Caution Tag On Inner Deck Lid Panel

A caution tag is located on the inner panel of the deck lid on all air suspension models (the inner floor pan of the spare tire compartment on Safari models) which cautions the owner to put the car in "CAR LIFT" before using the jack (See Fig. 1).

Make sure the owner is informed on this matter at the time of new car delivery.

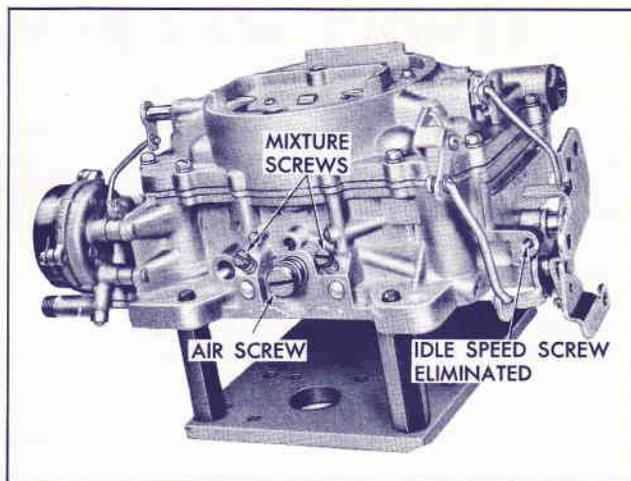
Fig. 9 New Carter Carburetor

In the new system idle air no longer flows past the throttle valves but is directed through a separate passage around the throttle valves and metered by the position of the by-pass air screw (See Fig. 9). The throttle valves are completely closed on hot idle.

NOTE: Always re-check idle mixture setting after making idle rpm adjustment with air screw.

The fast idle setting must be made after the idle speed and mixture adjustment. With the engine completely warmed up and the fast idle screw on the highest step of the fast idle cam, set the fast idle screw to give an engine speed of 2200 rpm.
